**LOWER ISSAQUAH CREEK RESTORATION AT LAKE SAMMAMISH
STATE PARK
PRELIMINARY DESIGN REPORT**

Northwest Hydraulic Consultants Inc.

The Watershed Company

18 September 2020

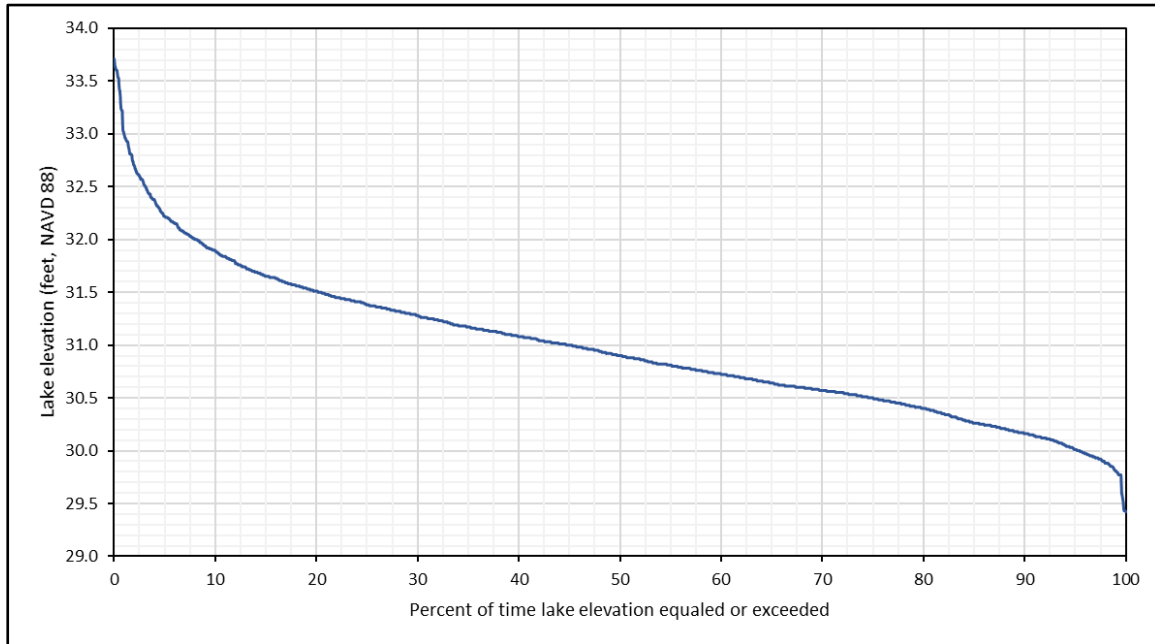
Figure 2. Lake Level Analysis for Lake Sammamish at USGS Gage Number 12122000 (Nov. Through Feb. Since 1998)

The USGS operates a continuous recording lake level gage (Gage Number 12122000) located on the west shore of Lake Sammamish near the outfall of Squibbs Creek. The gage is approximately 2.5 miles away from where Issaquah Creek enters into Lake Sammamish at its south shore. Lake elevation data at the gage has been available since 1996, with gage height data beginning in 1939. A lake level duration analysis was performed to assist in determining the appropriate lake levels that are to be used as the downstream boundary conditions for the hydraulic modeling (Section 8).

As described in a report for King County, prepared by NHC in 2013, the outlet weir of Lake Sammamish was modified in 1998, including raising the crest elevation by up to half a foot. Water levels in Lake Sammamish have consequently been affected. Therefore, the lake level analysis excluded data prior to 1998. The analysis was also limited to the months of November through February, which is when peak flows tend to occur on Issaquah Creek based on the historic record. This allowed for the best representation of lake levels to be used as a downstream boundary condition with the peak flow events being used in the hydraulic model (Section 8.1.3). In addition to this analysis, the lake levels during the February 6, 2020 event were assessed and used in modeling for this event (Section 8.1.3). Figure 2 contains the results of the duration analysis, with lake elevations on the vertical axis and the percent of time a lake elevation being equaled or exceeded along the horizontal axis. A summary of key percent exceedance values and the February 6, 2020 event, along with their corresponding lake levels, are included in Table 3.

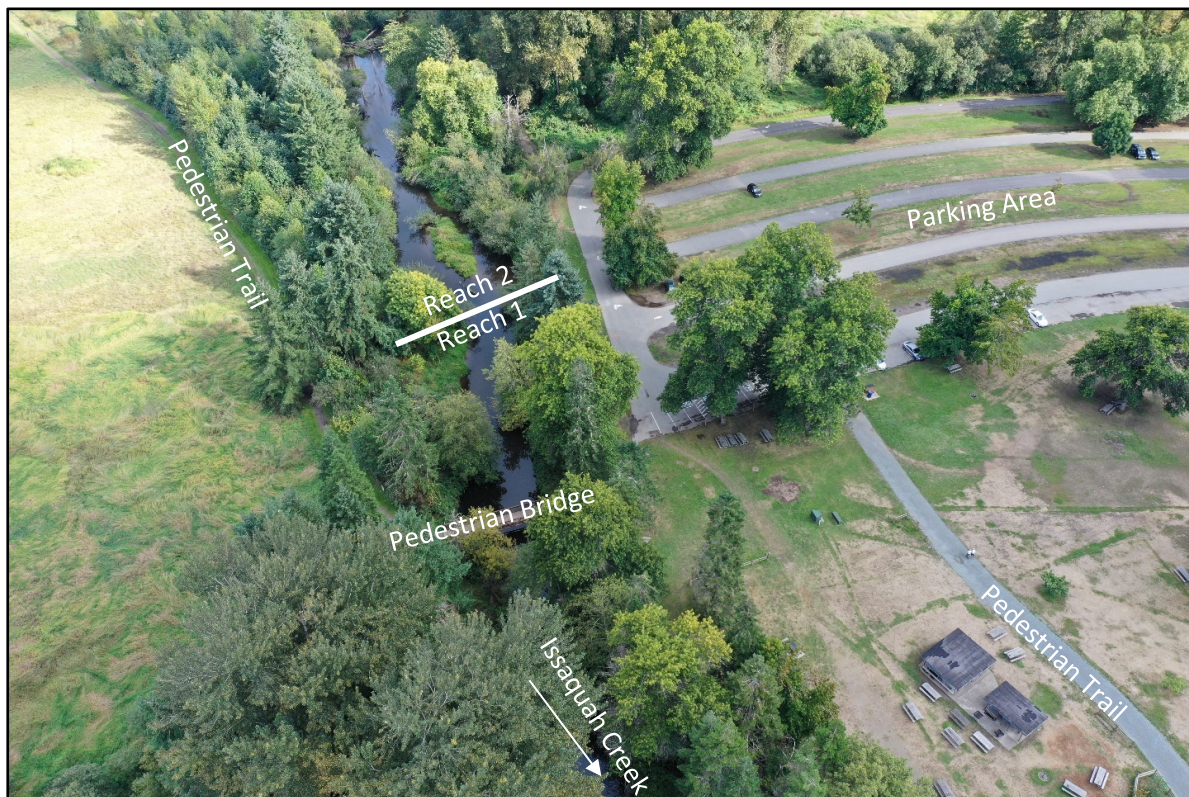
Photo 3. Reach 1 – Infrastructure

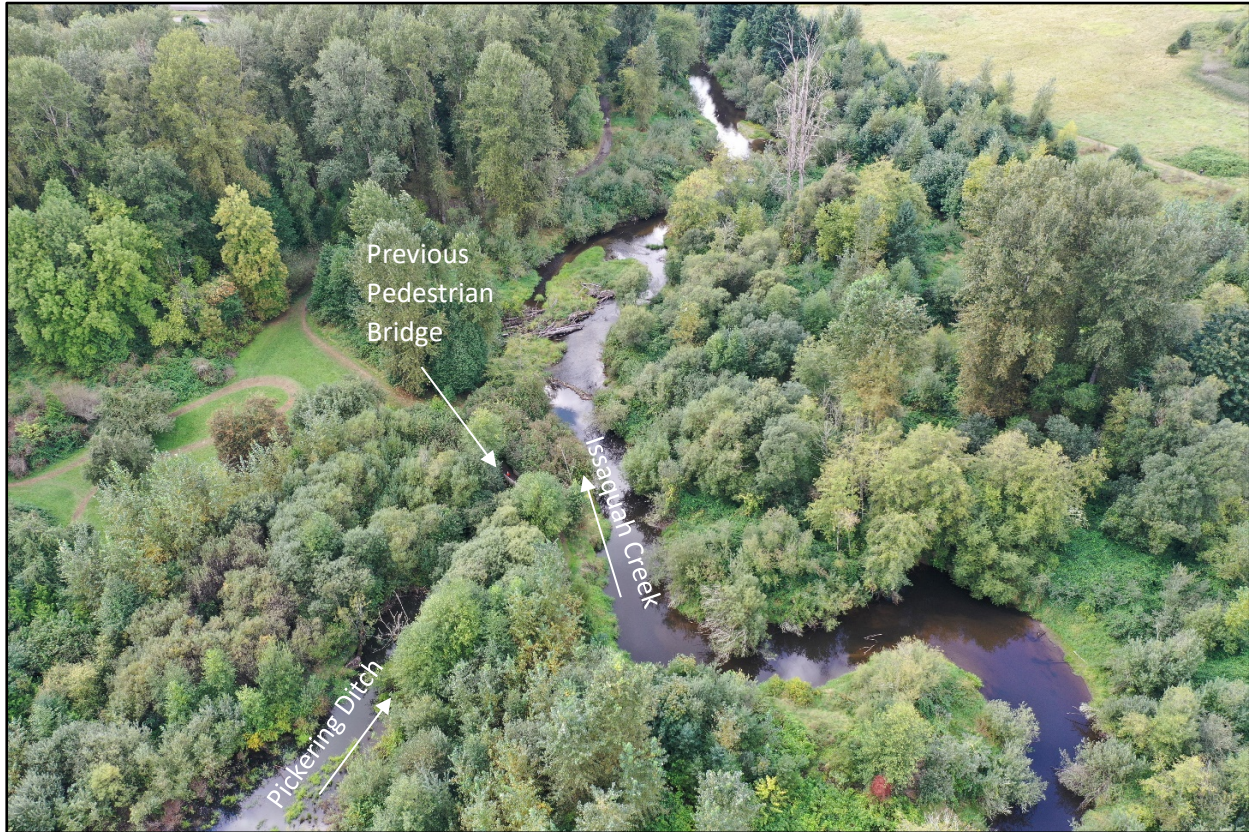
Photo 10. Reach 2 – Pickering Ditch

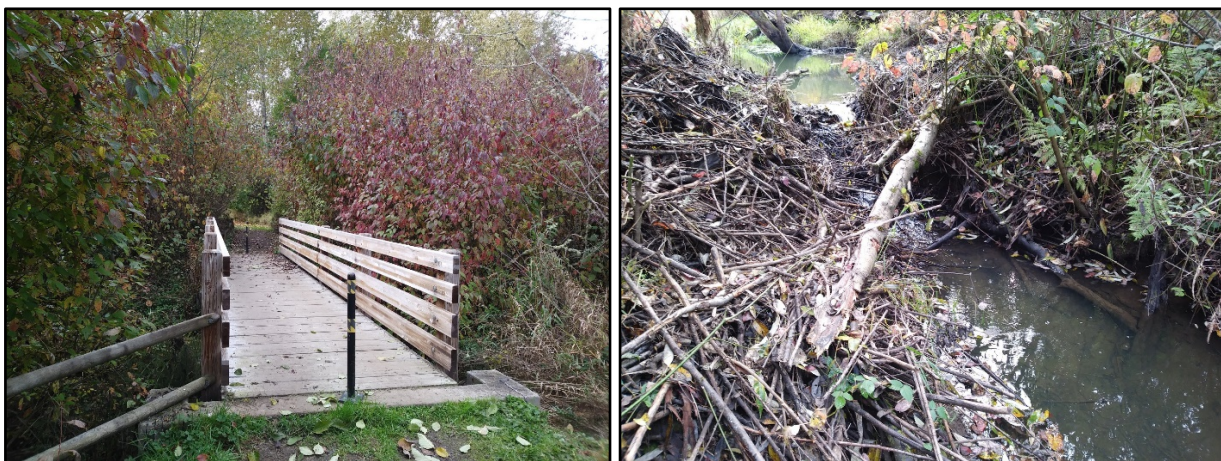
Photo 11. Pickering Ditch Previous Pedestrian Bridge (Left) and Beaver Dam Observed in Pickering Ditch in 2018 (Right)

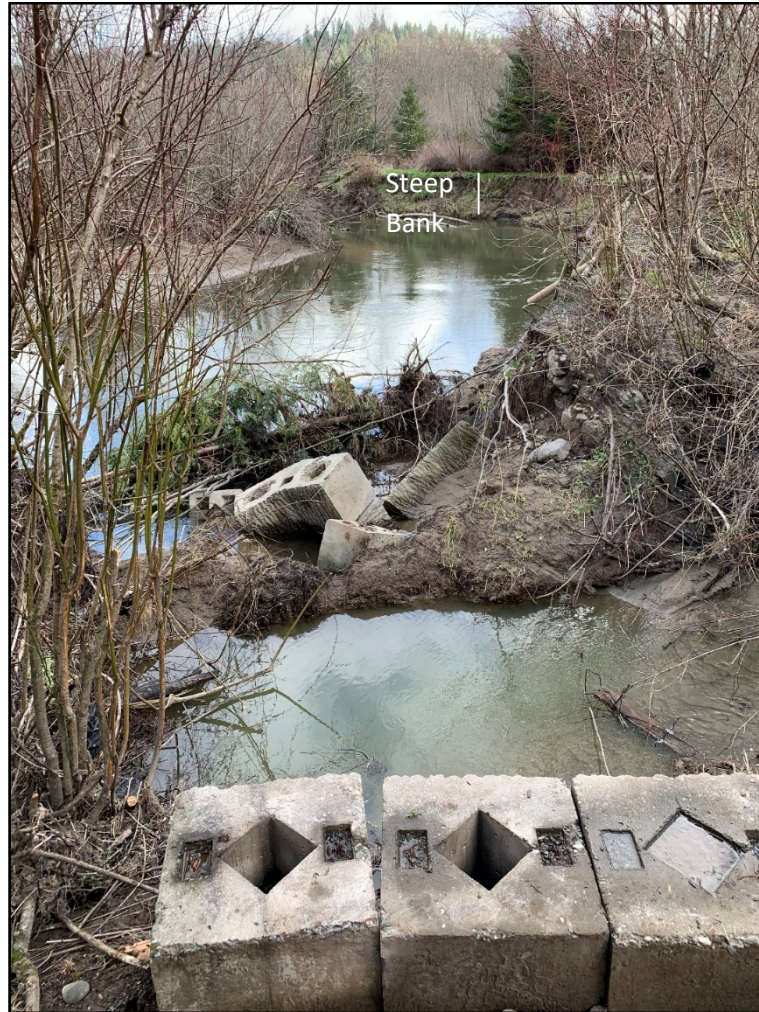
Photo 12. Pickering Ditch Failed Pedestrian Bridge (Photo Taken 2/26/2020)

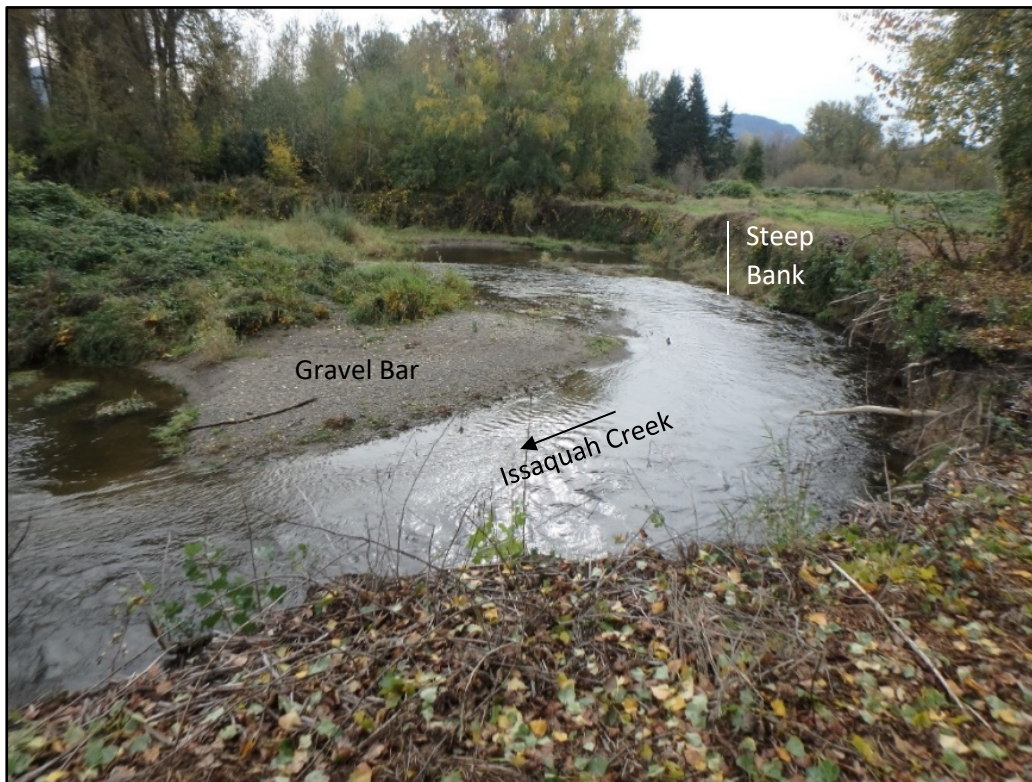
Photo 14. Example of Rapidly Growing Gravel Bar and Aggressively Migrating Meander in Reach 4; View is Looking Upstream from Approximately Chainage 5,000 (Photo Taken in Early 2017)

Similar to Reach 2, Reach 4 is an alluvial reach with diverse geomorphic conditions. Reach 4 is defined by the area where channel downcutting has been followed by channel widening and floodplain formation due to channel migration. For example, the growth of a gravel bar into this reach following initial downcutting at roughly Chainage 5,000 has resulted in persistent (reach-average rates of 4- to 8-feet per year) and, at times, rapid (up to a reach-average rate of 20-feet per year) channel migration (Photo 14). This has produced a reach with high hydraulic complexity including large areas of off-channel habitat (as well as one large backwater pool in an abandoned oxbow—Photo 15).

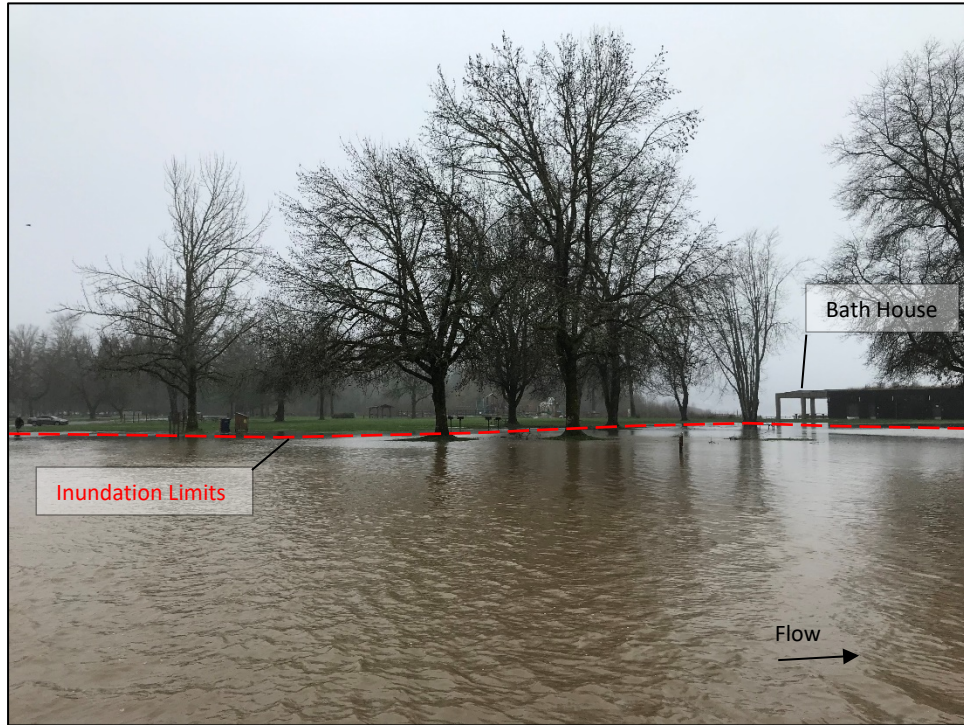
Figure 9. Inundation Extents of February 6, 2020 Flood Event Near Bath House

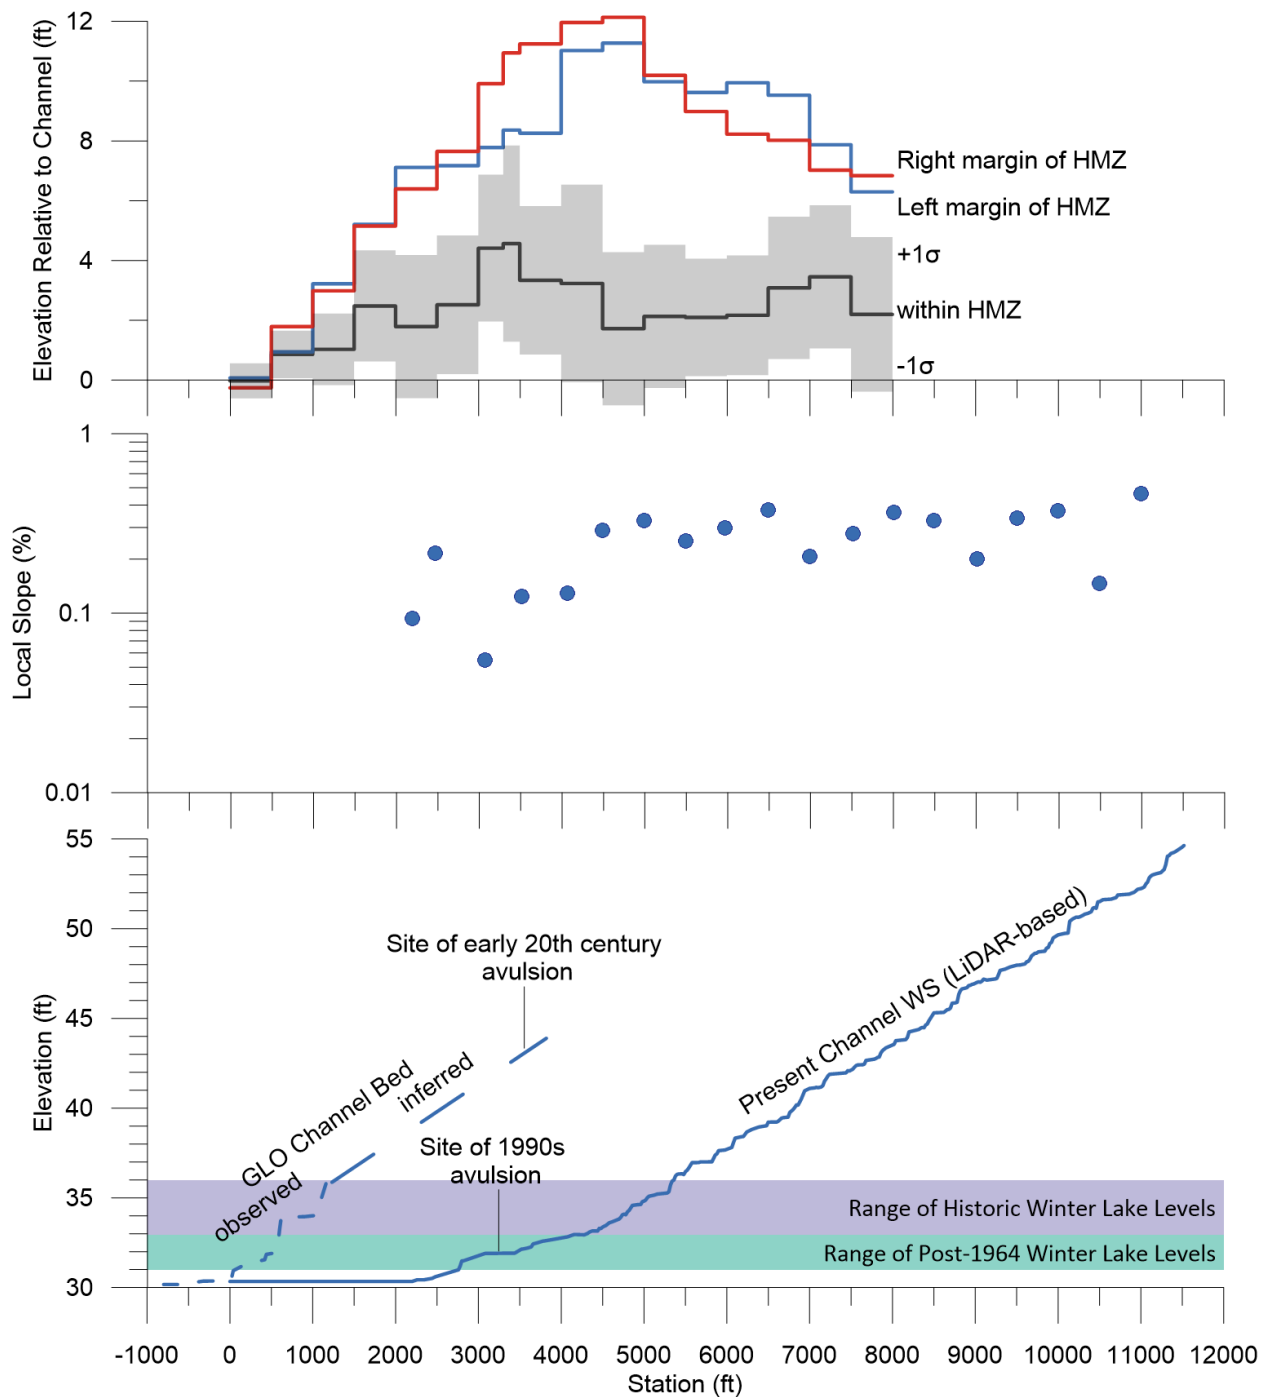
Figure 2: Profile of Lower Issaquah Creek (bottom) showing slopes of the present channel (middle), and bank heights and hypsometry of the surface within the historic channel migration zone (top).

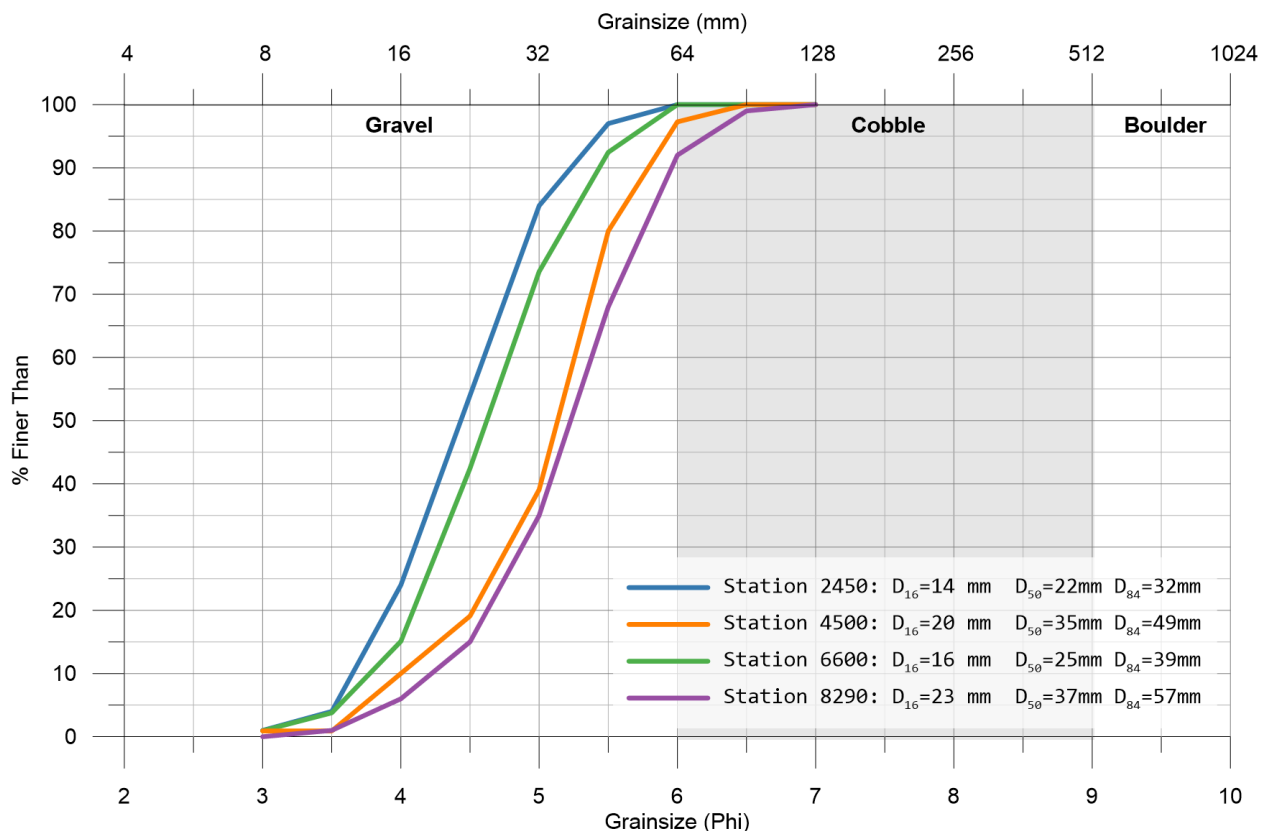
Figure 4: Observed surface grain size distributions based on Wolman pebble counts of bar and riffle-head locations.

The creek has bed material dominated by gravel- and cobble-sized sediment above approximately Station 4,000 and sand-dominated sediment below this. One isolated gravel bar is present at about Station 2,450. Pebble counts were collected at geomorphically-representative bar head locations along the channel profile to quantitatively characterize the texture of the bed material. The observed grain size distribution curves for the surface of four bars are shown in Figure 4.
