LOWER ISSAQUAH CREEK RESTORATION AT LAKE SAMMAMISH STATE PARK

PRELIMINARY DESIGN REPORT

18 September 2020

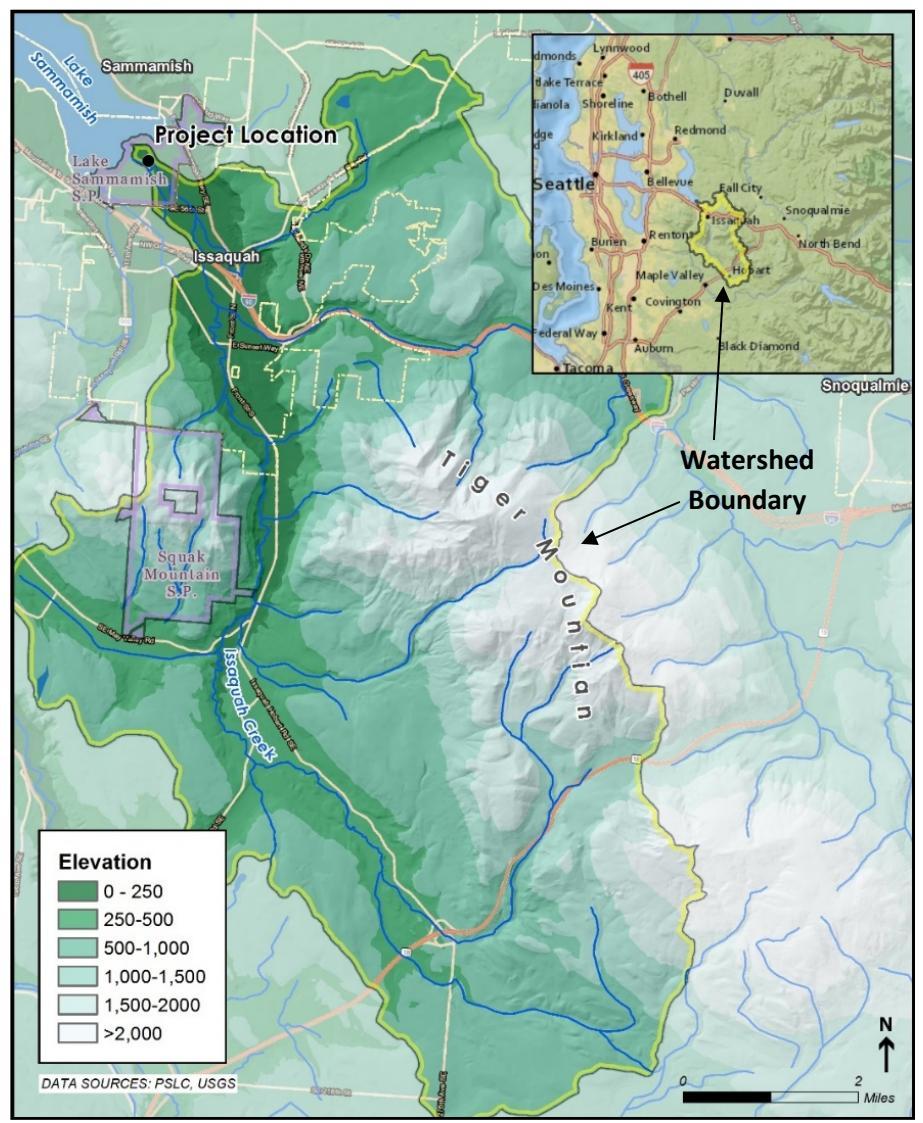
Issaquah Creek, at the mouth where it flows into Lake Sammamish, drains approximately 58.7 square miles, and receives a mean annual precipitation of 63 inches, as determined by PRISM rainfall data (PRISM Climate Group, 2019). The maximum and mean basin elevations are 2,990 feet and 897 feet, respectively. Issaquah Creek's headwaters originate in the steep slopes of the Squak, Cougar, Tiger, and Taylor Mountains (Figure 1). A significant portion of the basin's upper reaches reside in Washington State Forest Lands where development has been minimal; the lower reaches reside within Issaquah's city limits with an overall basin average canopy coverage of approximately 65.6%.

Figure 1. Project Location and Basin Overview

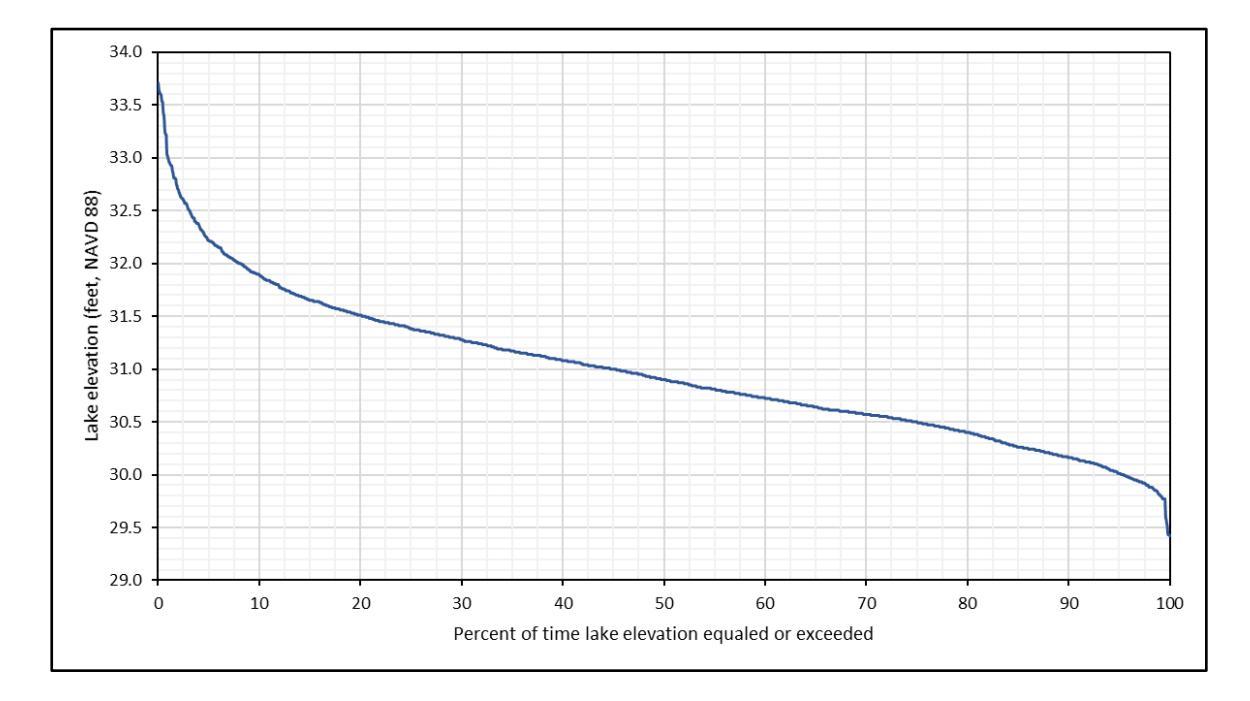
As described in a report for King County, prepared by NHC in 2013, the outlet weir of Lake Sammamish was modified in 1998, including raising the crest elevation by up to half a foot. Water levels in Lake Sammamish have consequently been affected. Therefore, the lake level analysis excluded data prior to 1998. The analysis was also limited to the months of November through February, which is when peak flows tend to occur on Issaquah Creek based on the historic record. This allowed for the best representation of lake levels to be used as a downstream boundary condition with the peak flow events being used in the hydraulic model (Section 8.1.3). In addition to this analysis, the lake levels during the February 6, 2020 event were assessed and used in modeling for this event (Section 8.1.3). Figure 2 contains the results of the duration analysis, with lake elevations on the vertical axis and the percent of time a lake elevation being equaled or exceeded along the horizontal axis. A summary of key percent exceedance values and the February 6, 2020 event, along with their corresponding lake levels, are included in Table 3.

Figure 2. Lake Level Analysis for Lake Sammamish at USGS Gage Number 12122000 (Nov. Through Feb. Since 1998)

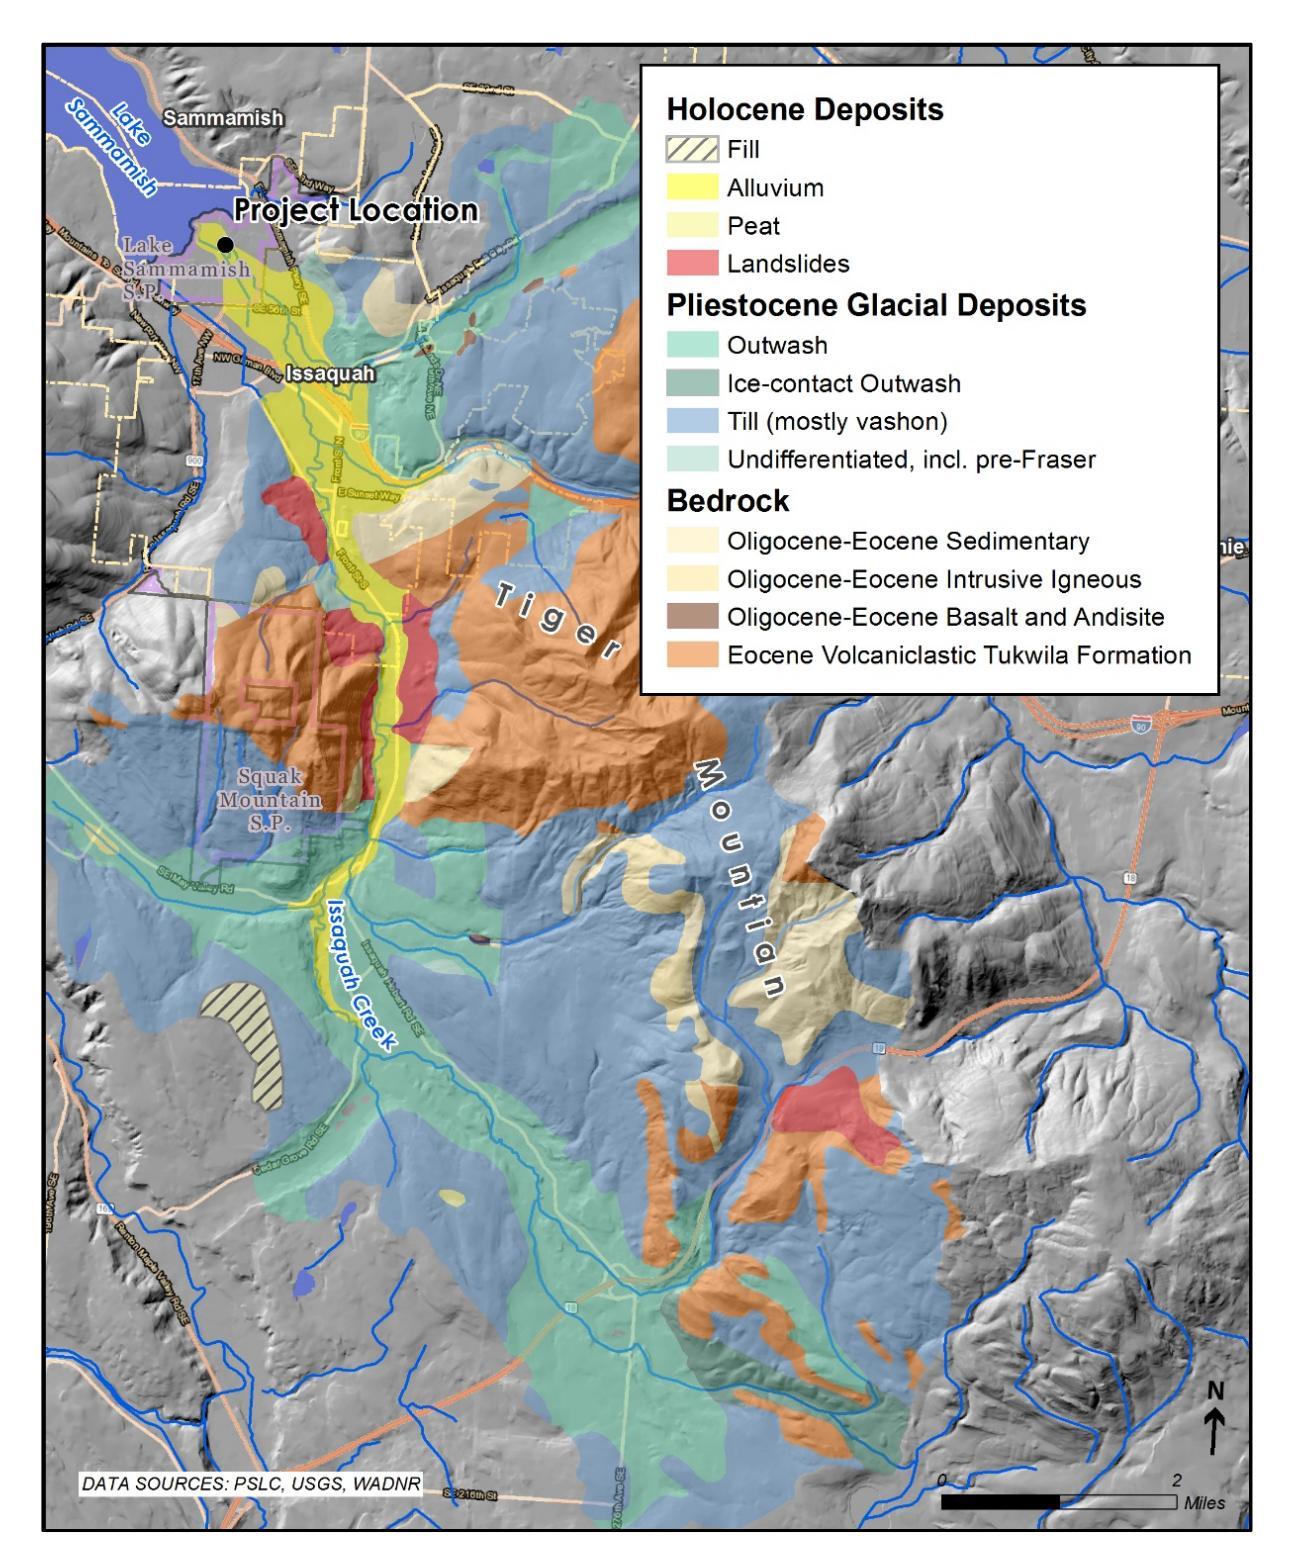
As discussed in Section 3, Issaquah Creek drains a basin of approximately 58.7 square miles that includes a heavily forest upper basin and a moderately developed lower basin. The mainstem of the creek follows a prominent glacial outwash channel (Figure 3) that formed during the recession of the Cordilleran Ice Sheet around 16,000 years ago (Booth et al., 2003) and has a correspondingly low gradient. In the upper basin, Issaquah Creek's main tributaries drain into the mountain slopes and are much steeper. The mountains are mantled by till and underlain by a folded sequence of Oligocene-Eocene aged sedimentary and volcanic rocks, including the Tukwila, Ranging River, and Renton Formations. Extensive coal mining occurred in the Renton Formation beginning in the late 19th century and some resulting tailings have impacted the creek.

Figure 3. Generalized Geology of the Issaquah Creek Basin Derived From Division of Geology (2010)

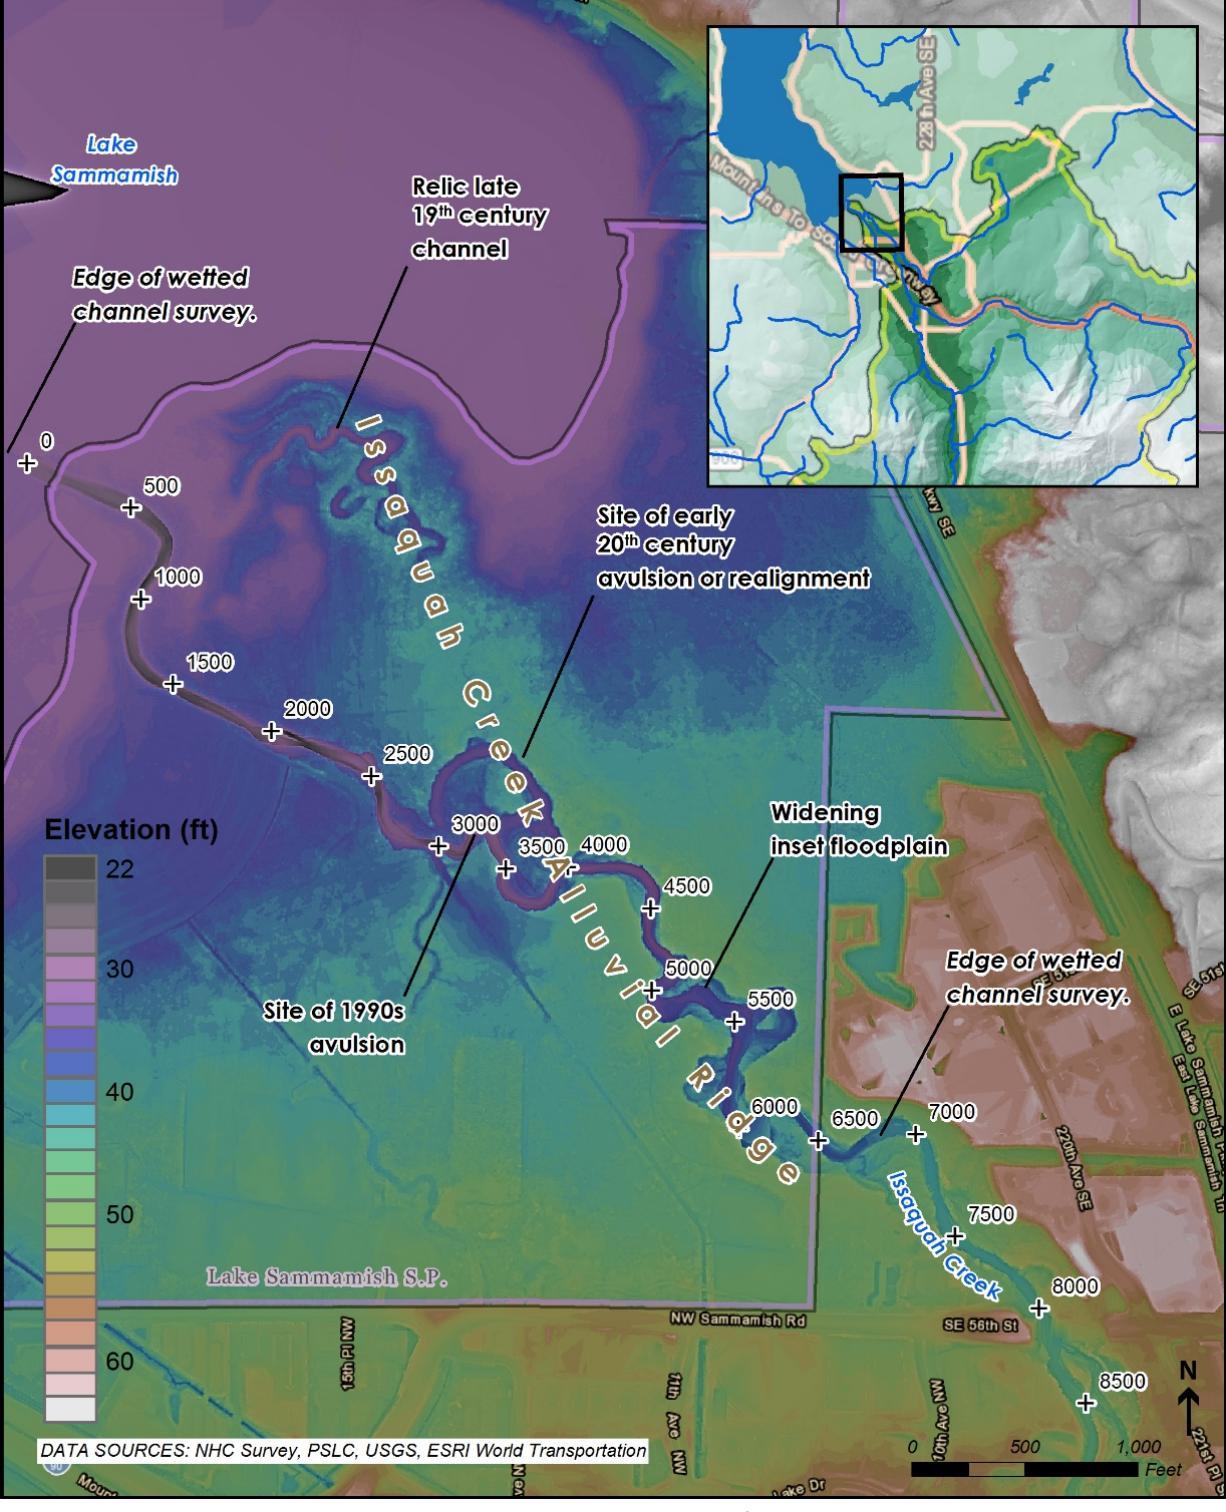
Figure 4. Topographic Base Map of Study Reach

Reach 3 occurs immediately upstream of the site of the late nineteenth/early twentieth century avulsion (Figure 4). It is highly entrenched, with 8- to 12-feet of offset between the elevation of inset floodplain features and the top of the bank. The reach is immediately above the gravel to sand transition, has gravel-dominated substrate, and a strongly concave profile. Lateral channel migration in the reach has been extremely limited, leaving a straight channel with steep banks, little hydraulic diversity, and almost no off-channel refugia habitat (Photo 13).

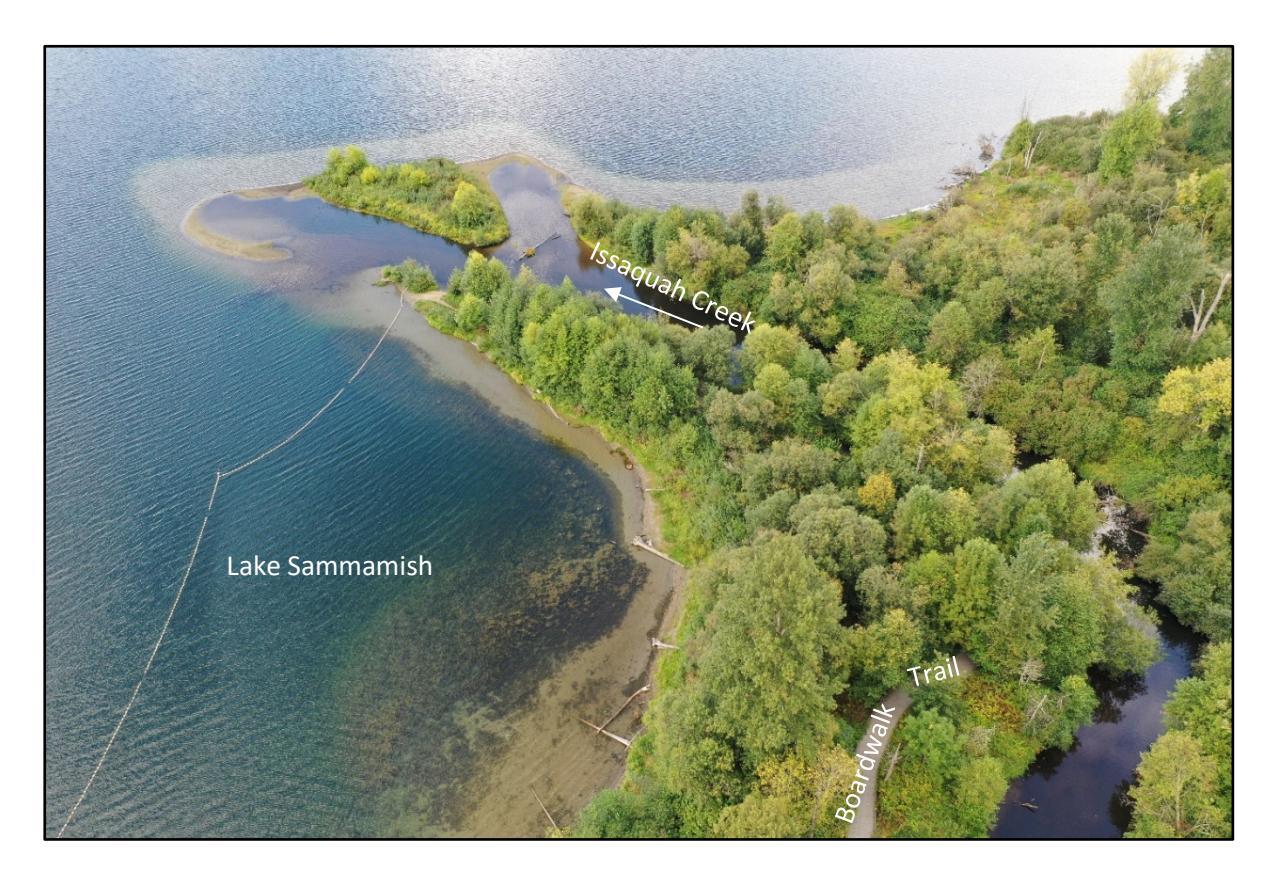
Reach 1 consists of the transition zone from Issaquah Creek into Lake Sammamish (Appendix E and Photo 1). This reach is a relatively stable segment of channel that is heavily influenced by Lake Sammamish. At low flow, the water surface is functionally flat and there is very little current. The bed material is dominated by sand and fine sediments, although some fine to medium-sized gravel is transported through this reach during large floods. Mature trees line the channel banks (Photo 2) and large wood is recruited to the channel primarily by windthrow, and possibly by undercutting of the banks.

Photo 1. Reach 1 – Issaquah Creek Outlet into Lake Sammamish

Several existing trails are located along both river banks, including a Boardwalk Trail along the left bank between roughly Chainage 500 and 1,400 (Photo 1 and Appendix E) and an existing pedestrian bridge crossing Issaquah Creek at approximately Chainage 1,750 (Photo 3, Photo 4, and Appendix E). A large parking area with a bathhouse is located southwest of the creek in Reach 1 as well. Appendix A depicts the existing infrastructure included in Reach 1.

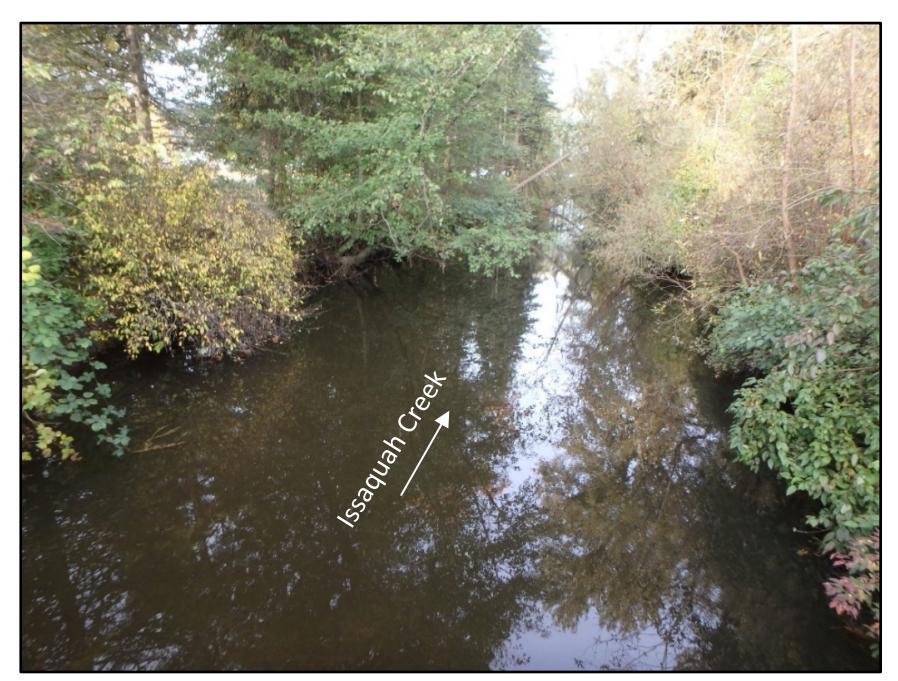
Photo 2. Reach 1 - View Looking Downstream from Existing Pedestrian Bridge at Chainage 1,750

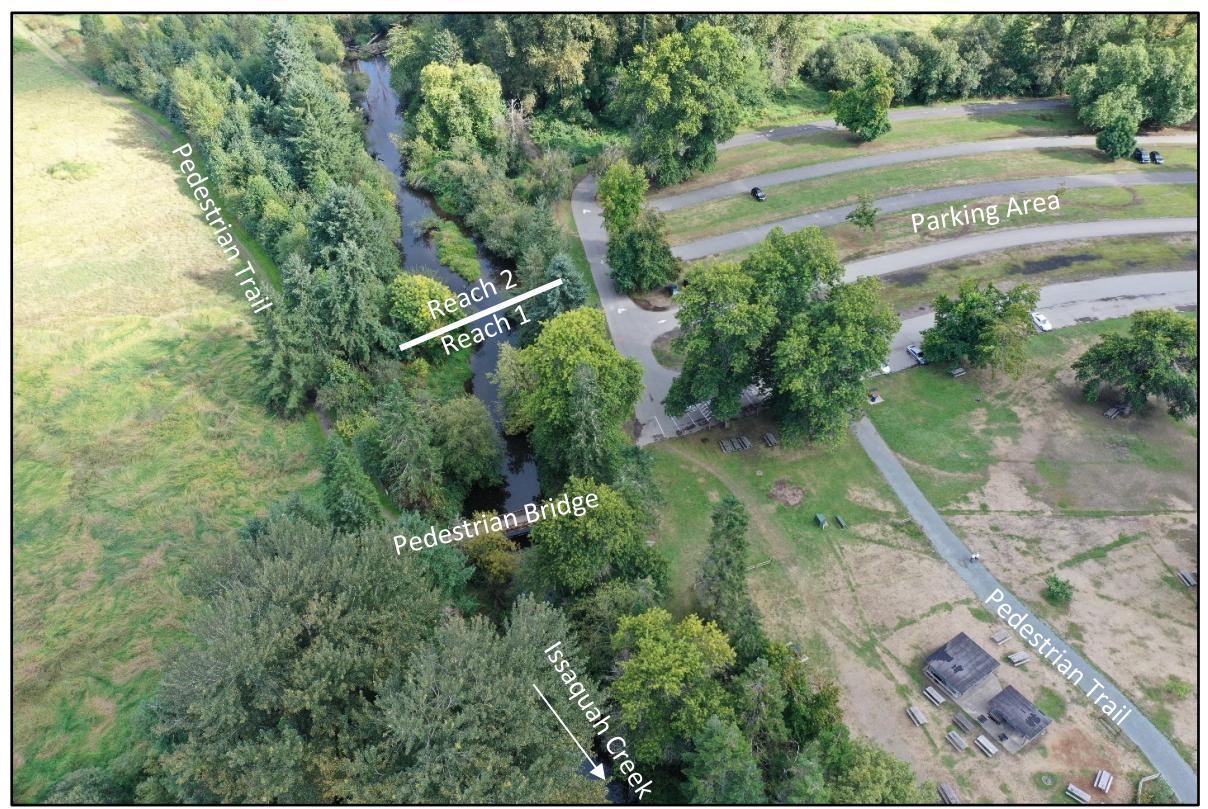
Photo 3. Reach 1 – Infrastructure

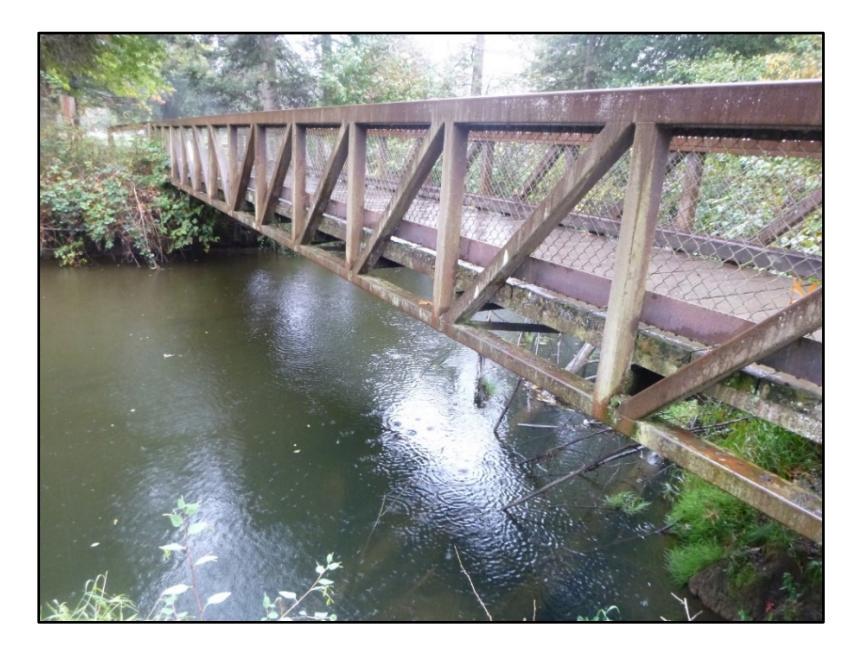
Photo 4. Pedestrian Trail Crossing Issaquah Creek in Reach 1

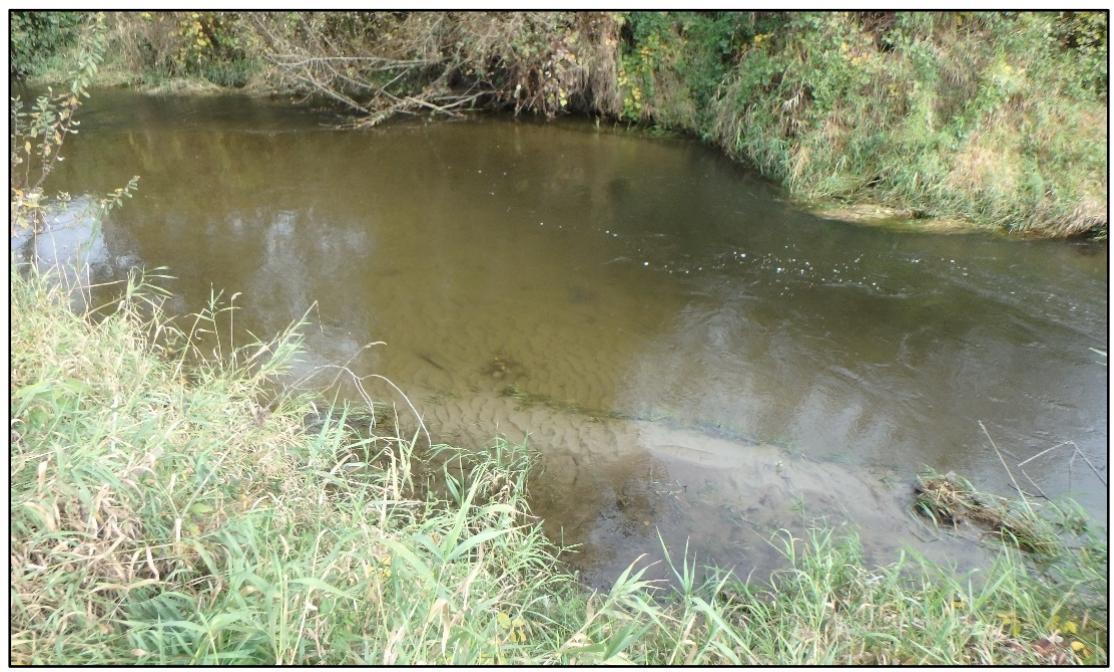
Photo 5. Characteristic Sandy Substrate for Reach 2 at Chainage 3,900, Just Below the Gravel to Sand Transition

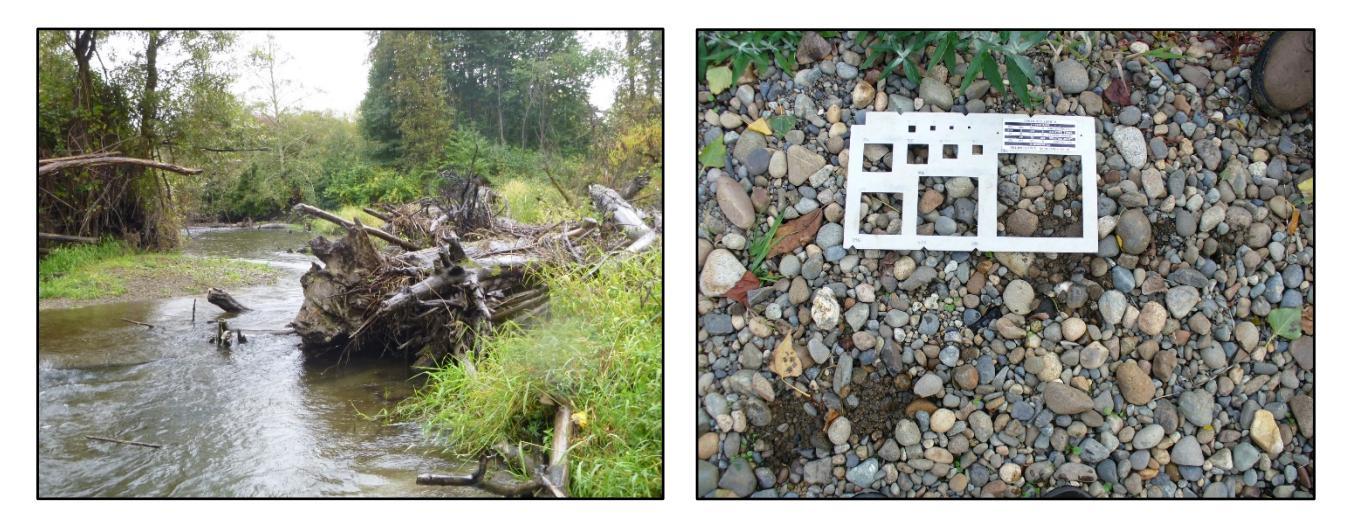
Photo 6. Location of Pebble Count and LWM Jam Upstream in Reach 2 at Chainage 2,400 (Left) and Material Sampled (Right)

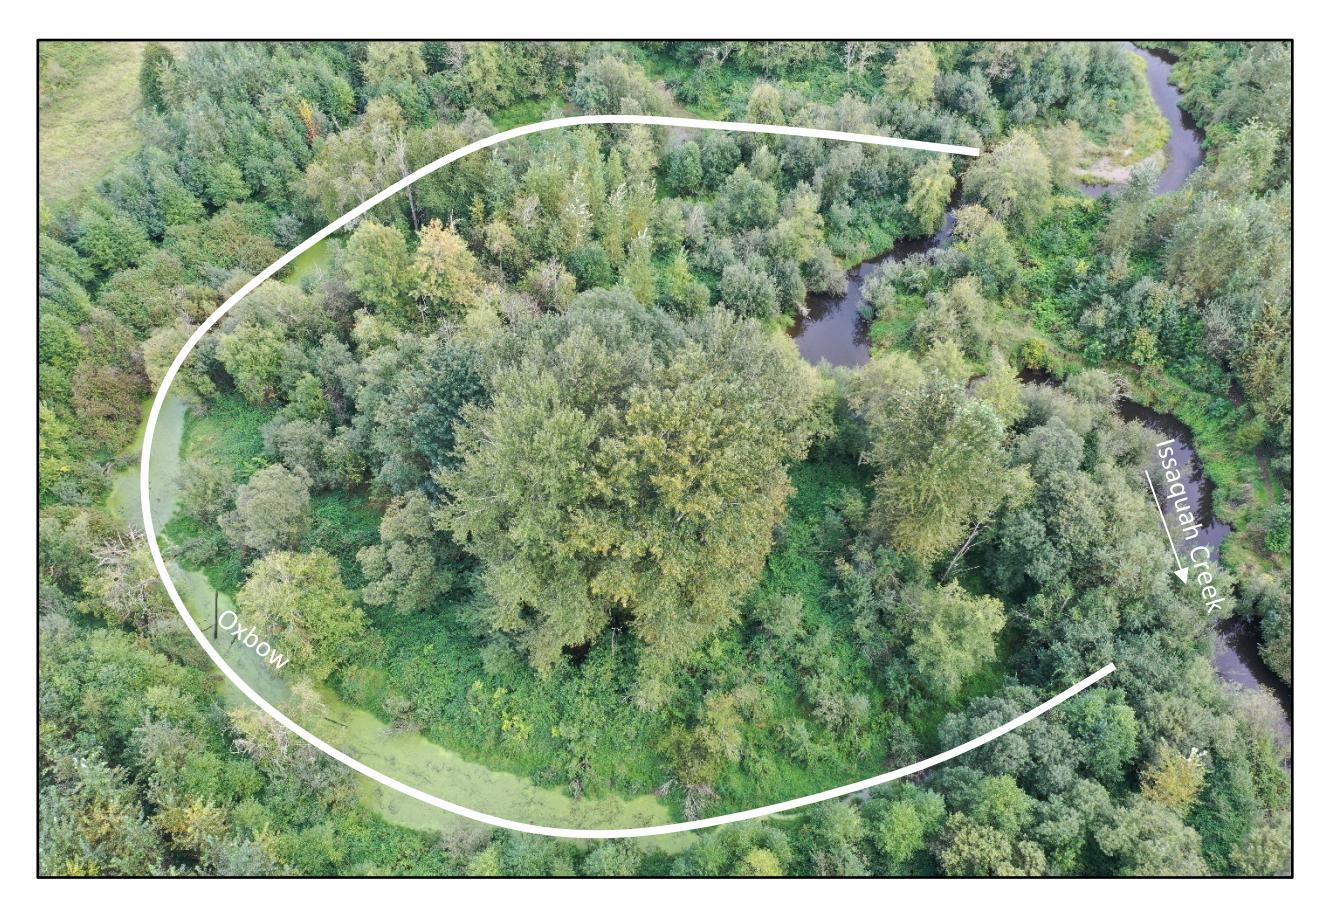
Photo 7. Reach 2 – Oxbow Aerial Photo

meander cut-off avulsion in the 1990s left a large remnant low elevation oxbow feature in the floodplain that provides off-channel refugia habitat (Appendix E, Reach 2, Photo 7, and Photo 8).

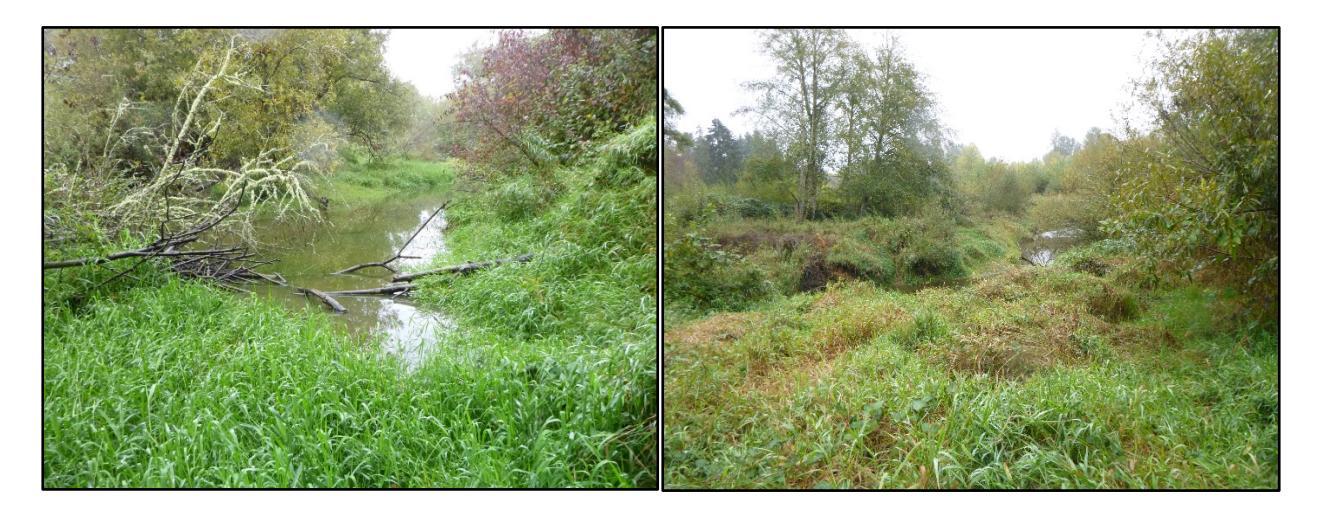
Photo 8. Reach 2 – Oxbow

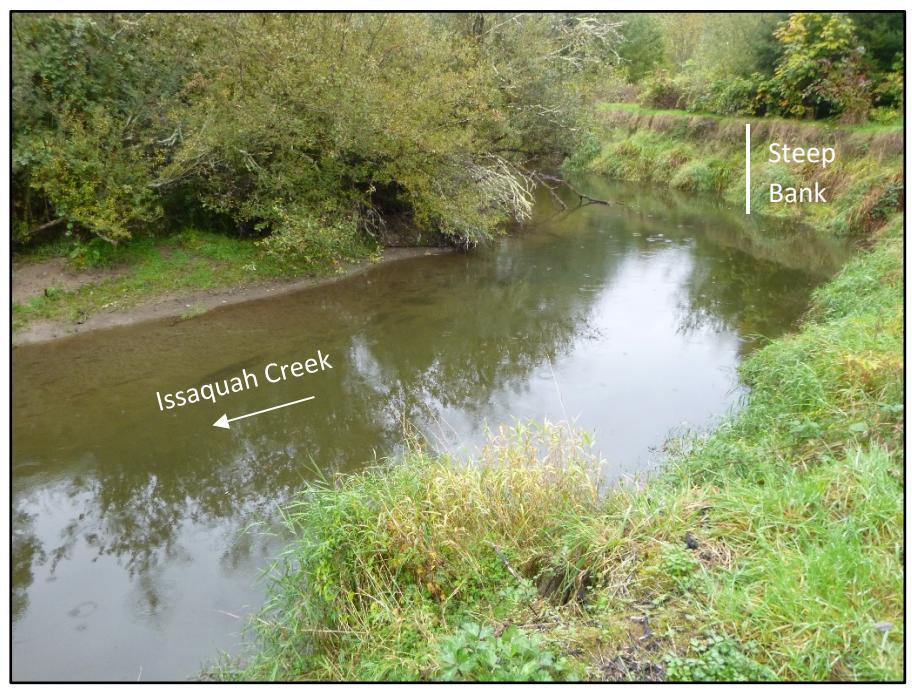
Photo 9. Steep Bank from Channel Migration, Looking Upstream from Approximately Chainage 3,600 (Photo Taken 10/08/2018)

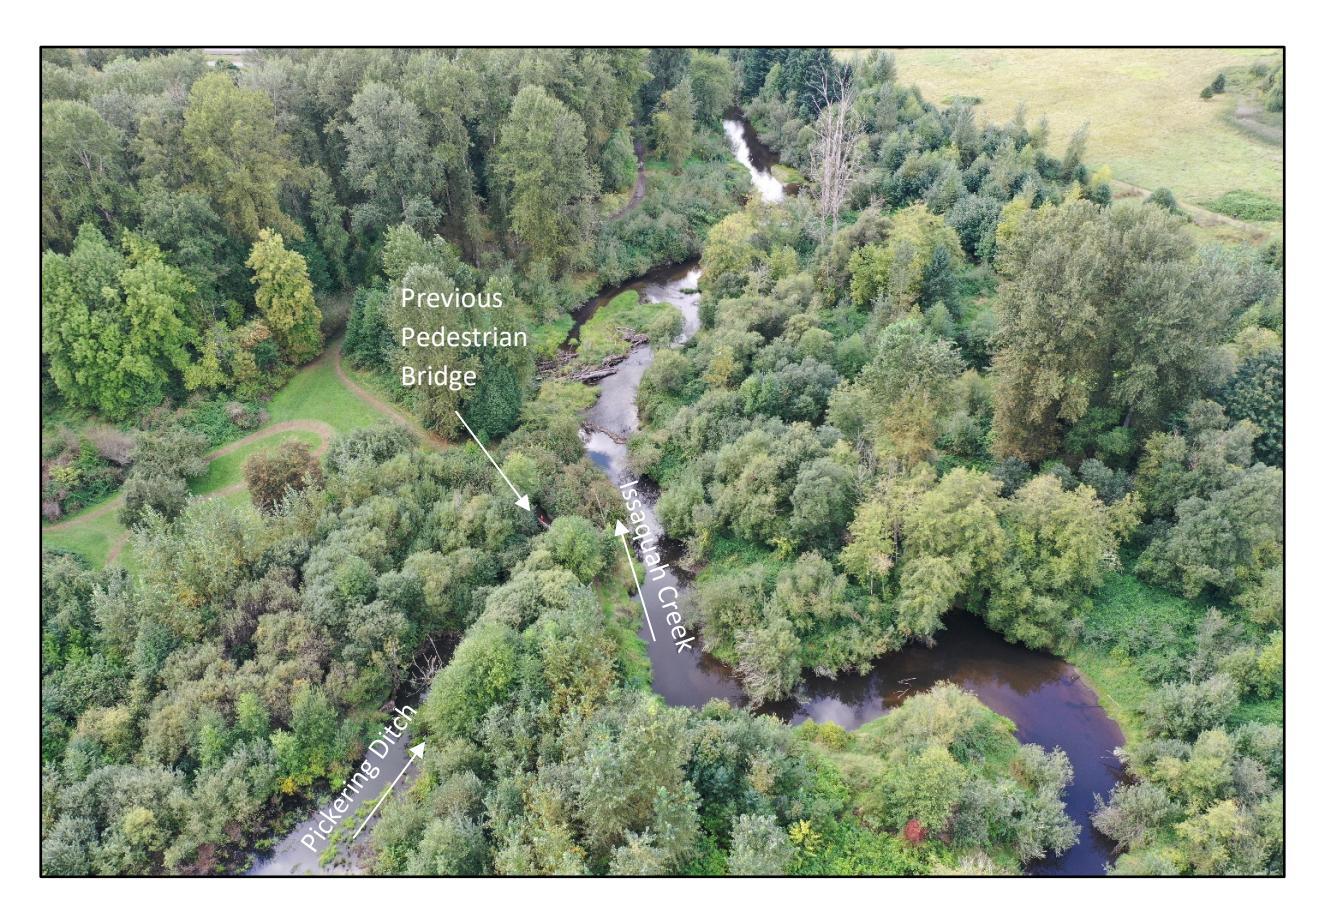
Photo 10. Reach 2 – Pickering Ditch

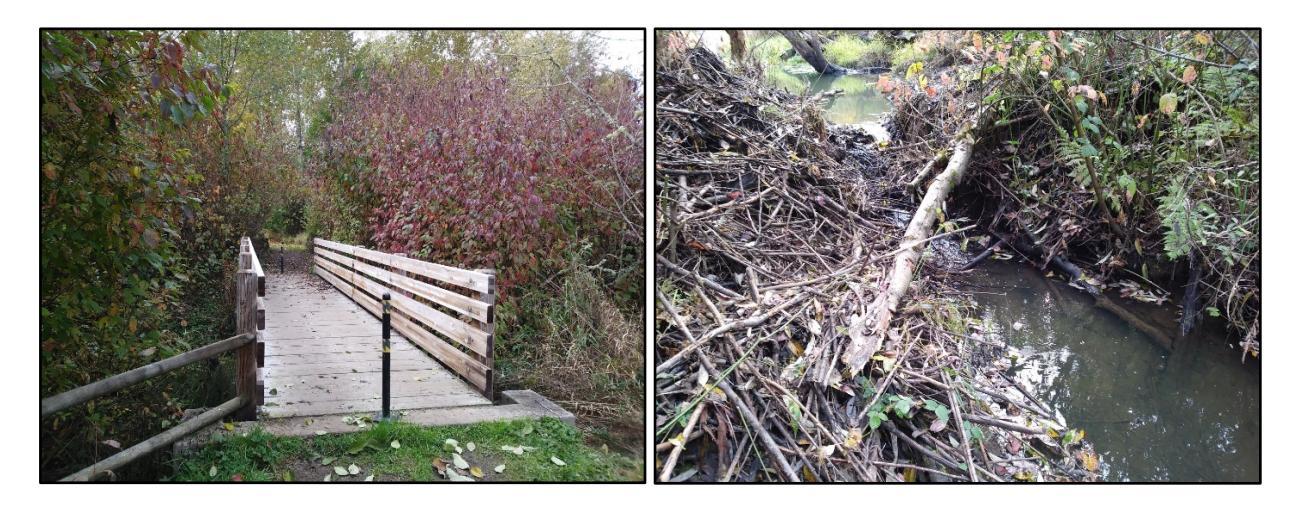
Photo 11. Pickering Ditch Previous Pedestrian Bridge (Left) and Beaver Dam Observed in Pickering Ditch in 2018 (Right)

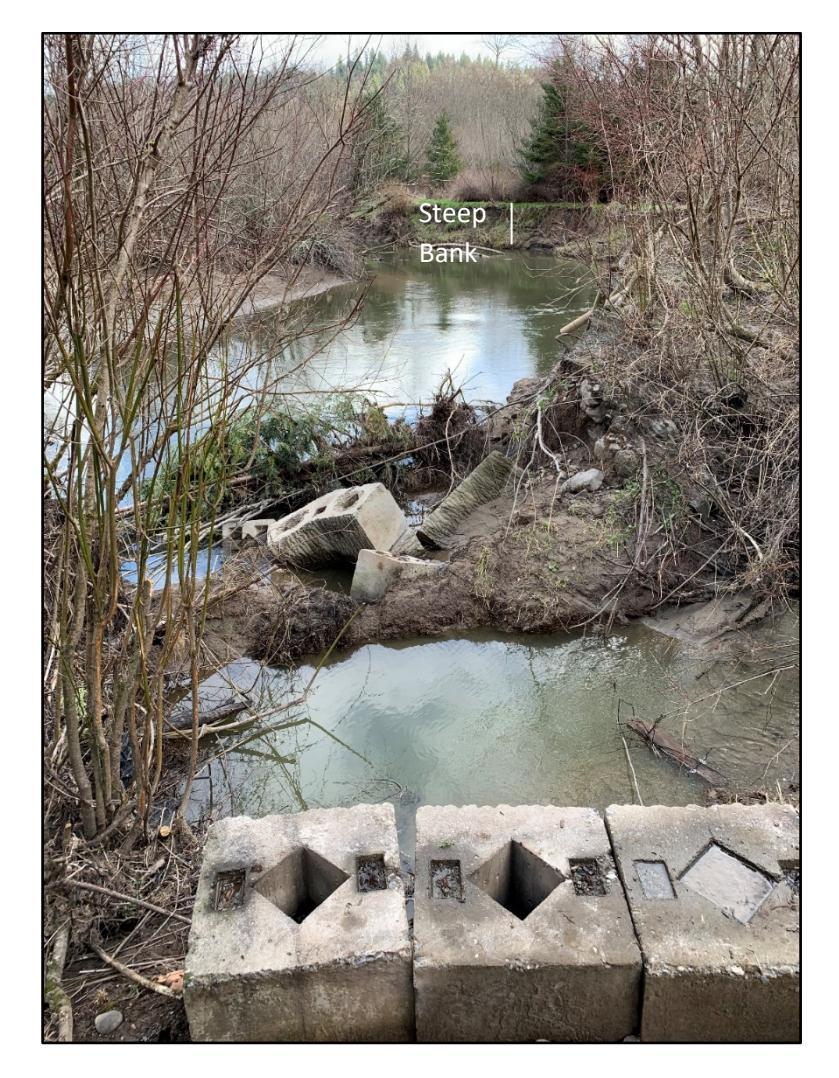
Photo 12. Pickering Ditch Failed Pedestrian Bridge (Photo Taken 2/26/2020)

In addition to the abrupt avulsion event that resulted in the formation of an oxbow, persistent lateral channel migration in this reach has recruited LWM, which has accumulated into two prominent log jams (Appendix E, Reach 2). Local erosion is occurring around these jams, indicating the potential for local flow obstructions to concentrate flow and migrate, widening the channel area. Deep scour also occurs around small flow obstructions within this reach, probably due to the relatively fine bed material. Photo 9 depicts the nearly vertical bank remaining because of the persistent lateral channel migration. In early 2020, high peak flow events further eroded the bank in Photo 9, and contributed to the failure of the pedestrian trail crossing the Pickering Ditch (see Section 4.6.3 and Photo 12).

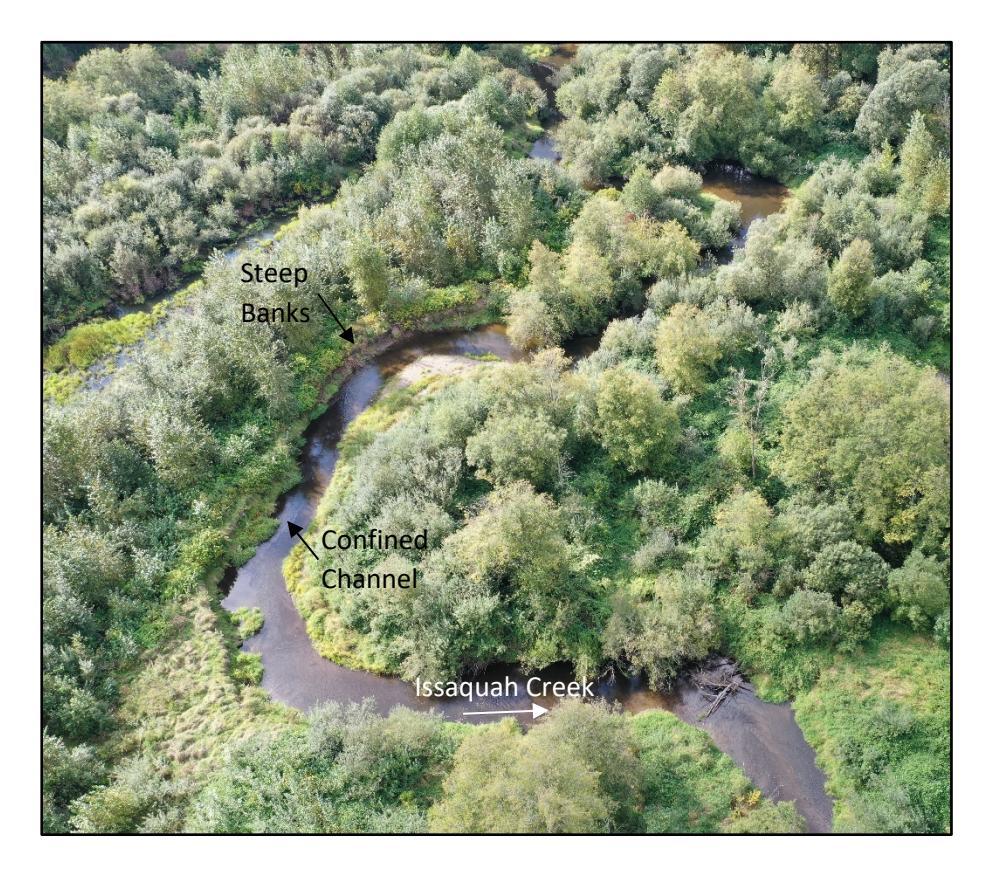
Photo 13. Reach 3 – Channel Confinement and Steep Banks

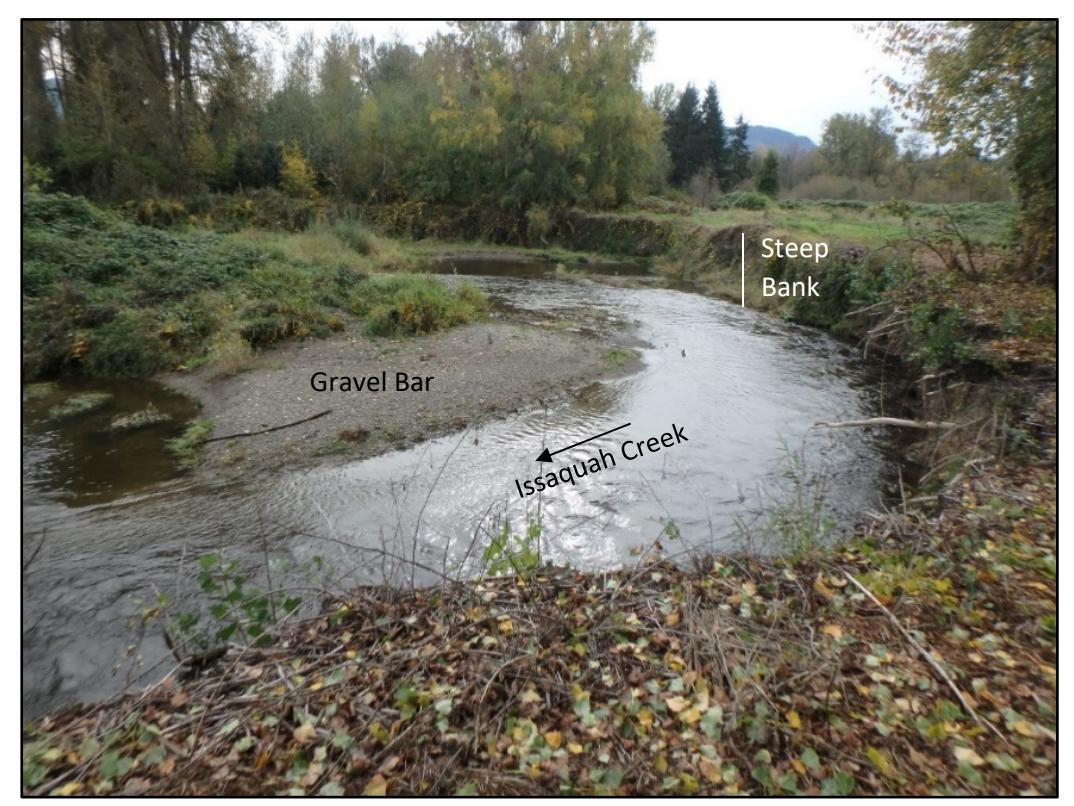
Photo 14. Example of Rapidly Growing Gravel Bar and Aggressively Migrating Meander in Reach 4; View is Looking Upstream from Approximately Chainage 5,000 (Photo Taken in Early 2017)

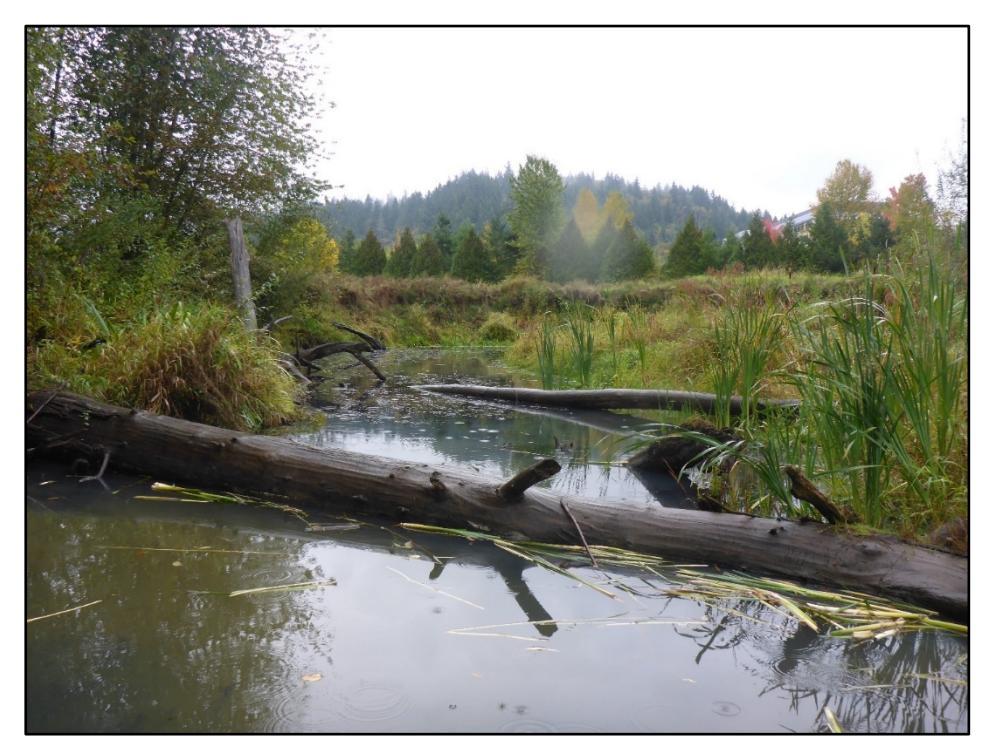
Similar to Reach 2, Reach 4 is an alluvial reach with diverse geomorphic conditions. Reach 4 is defined by the area where channel downcutting has been followed by channel widening and floodplain formation due to channel migration. For example, the growth of a gravel bar into this reach following initial downcutting at roughly Chainage 5,000 has resulted in persistent (reach-average rates of 4- to 8-feet per year) and, at times, rapid (up to a reach-average rate of 20-feet per year) channel migration (Photo 14). This has produced a reach with high hydraulic complexity including large areas of off-channel habitat (as well as one large backwater pool in an abandoned oxbow—Photo 15).

Photo 15. Large Backwater Pool in Oxbow at Approximately Chainage 5,400

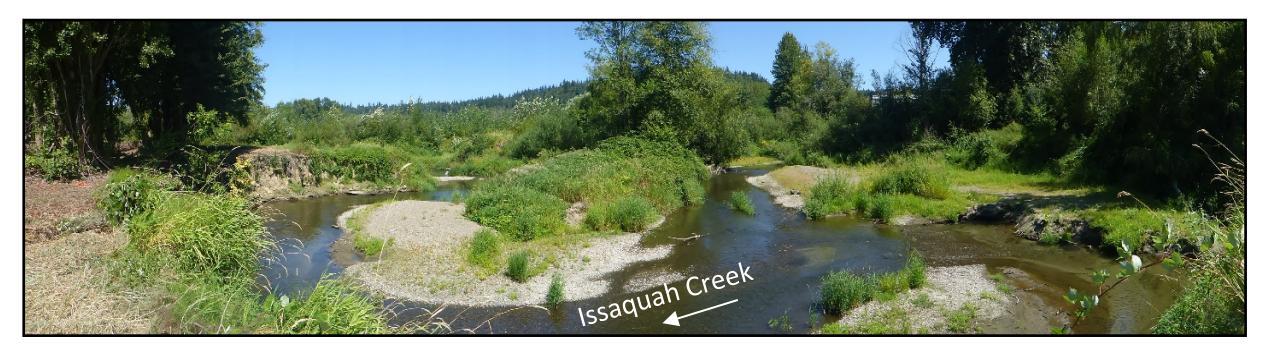
Photo 16. Gravel Bar Growth in Reach 4 Before LWM Recruitment (Photo Taken in 2018)

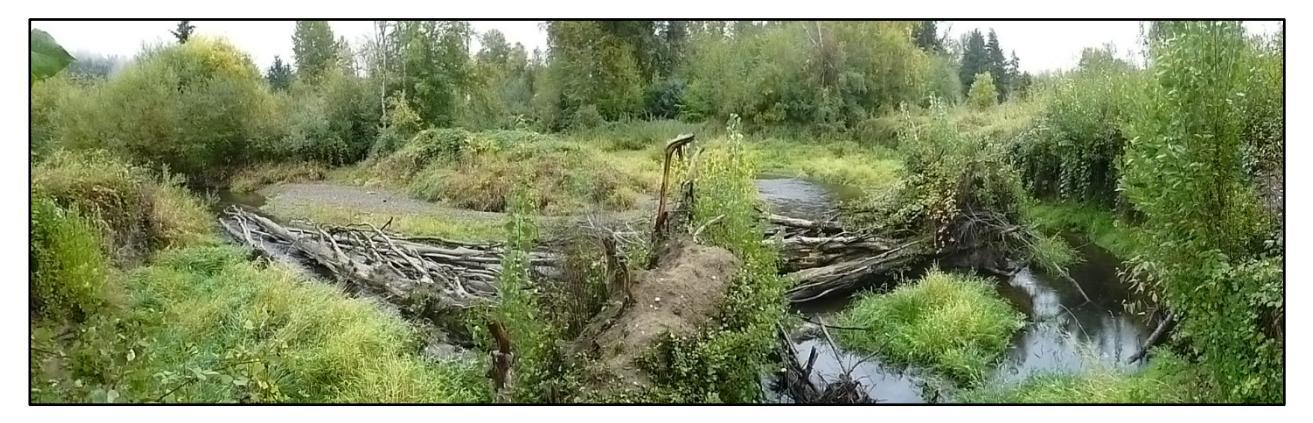
Photo 17. Gravel Bar Growth in Reach 4 After LWM Recruitment (Photo Taken in 2019)

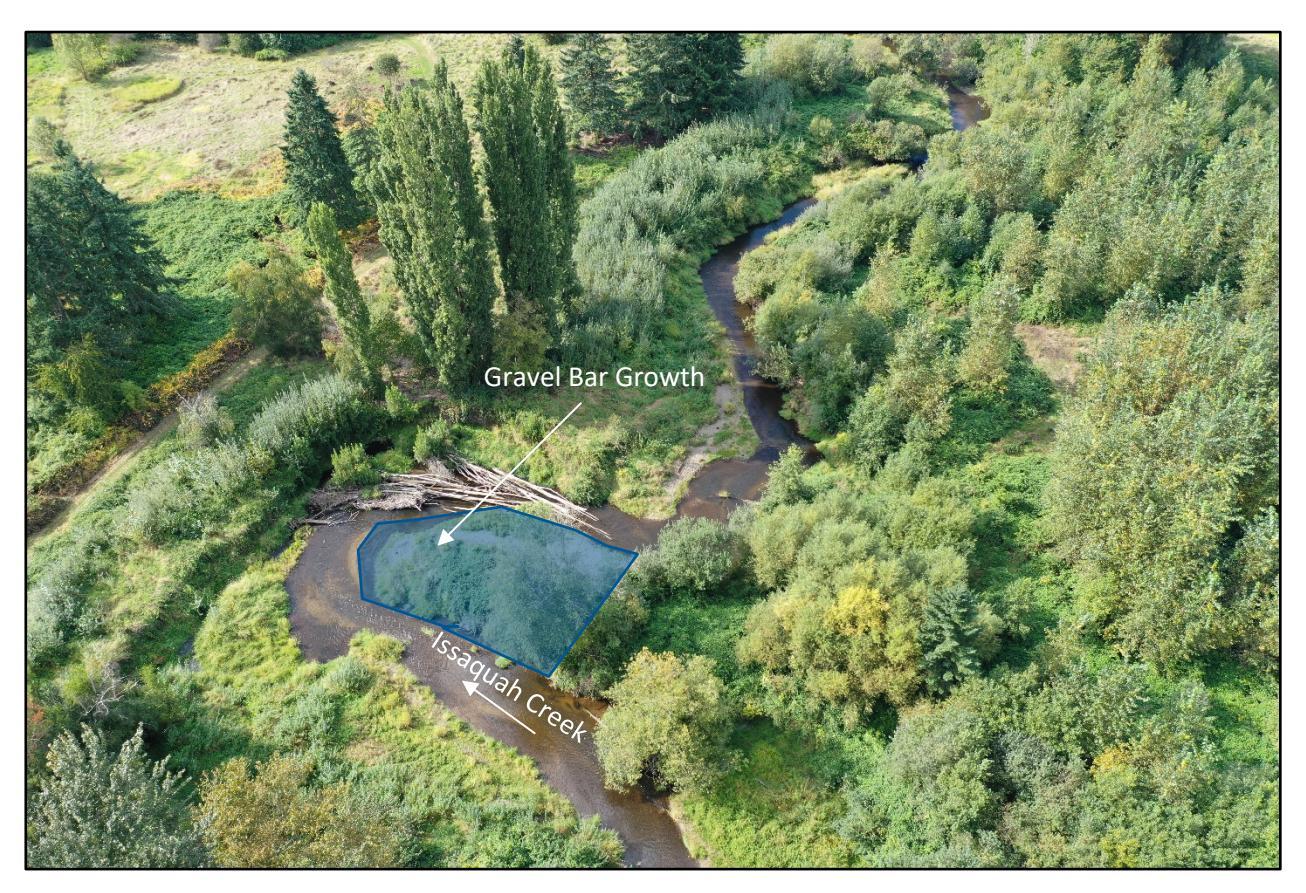
Photo 18. Ariel View of Gravel Bar Growth and LWM Recruitment (Photo Taken in 2019)
