LOWER ISSAQUAH CREEK RESTORATION AT LAKE SAMMAMISH STATE PARK

PRELIMINARY DESIGN REPORT

18 September 2020

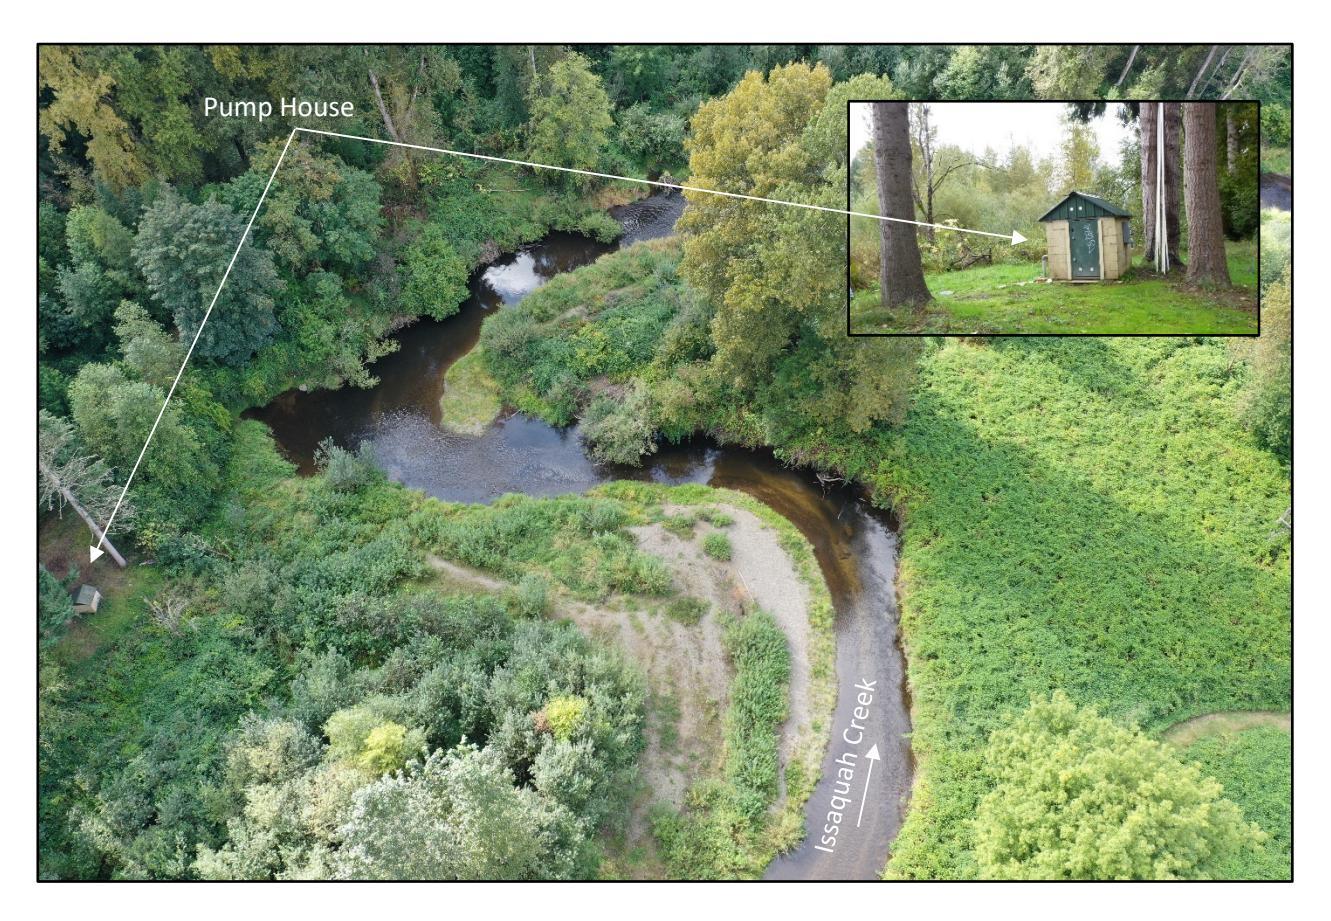
Reach 4 includes existing trails along the top of both riverbanks as well as a pump house located on the left bank at about Chainage 6,100 (Photo 19). Trails on both sides of the creek are set back into the riparian zone (Appendix A and Appendix E, Reach 4). Rock riprap currently resides along the left bank of the channel near the pump house. The material does not appear to be maintained, allowing the channel to undercut the banks. As such, this material was not considered a permanent feature, contributing to a Disconnected Migration Area in the CMZ analysis (Appendix D). Per discussions with State Parks, the pump house was determined to be critical park infrastructure and, as discussed further in Sections 7.4.3 and 8.5.2, was taken into consideration during the design and hydraulic analysis of the preferred alternative. The need for the existing pump house and/or its protection is currently being evaluated by State Parks. As the project progresses, further investigation of potential benefits/impacts to relocating the pump house or protecting the existing infrastructure will continue to be examined and discussed with State Parks in order to develop a multi-beneficial project.

Photo 19. Existing Pump House in Reach 4

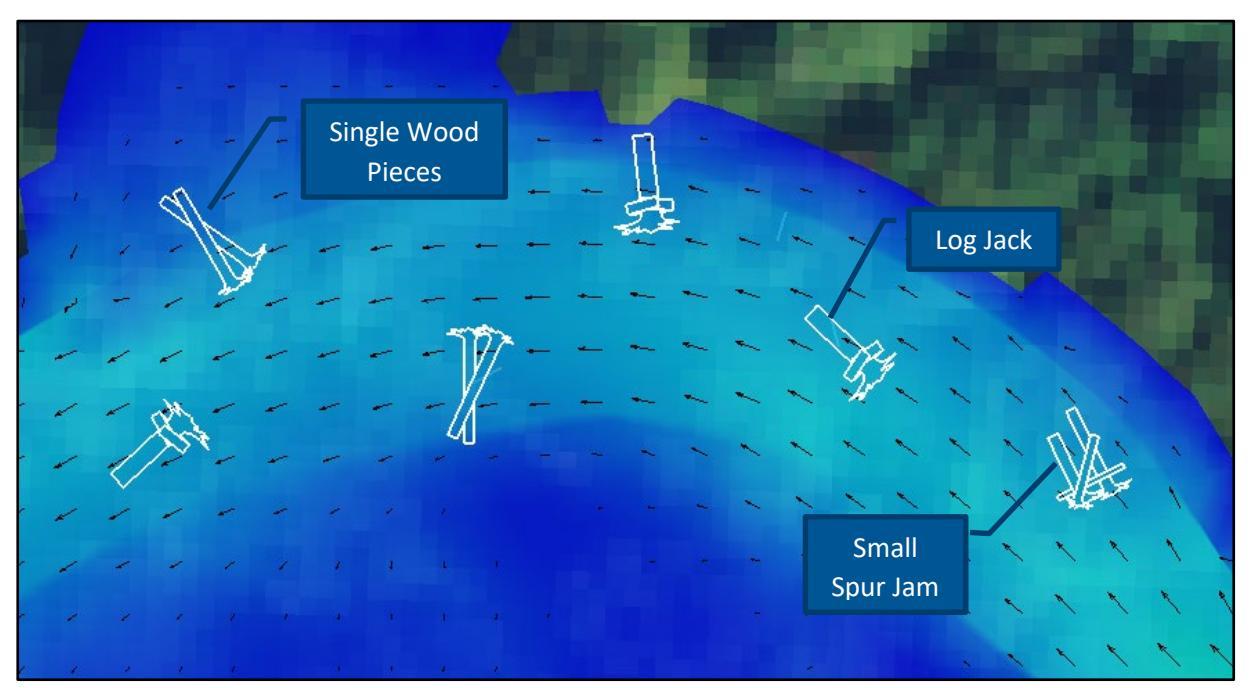
Figure 5 depicts an example layout of the single wood pieces (shown here as two overlapping pieces of wood), the log jacks, and the small spur jams. The single wood pieces are 2-foot in diameter and 25-foot long logs with rootwads (see Appendix F, Sheets LWM 1 and LWM 2). The log jacks consist of one, 3-foot diameter, 15-foot long log with rootwad and three, 2-foot diameter, 10-foot long logs without rootwads (see Appendix F, Sheet LWM 3). The small spur jams consist of one, 2-foot diameter, 20-foot long log with rootwad; two, 2-foot diameter, 15-foot long logs with rootwads; and one, 1-foot diameter, 10-foot long log with rootwad (see Appendix F, Sheet LWM 4). These structures are strategically placed throughout the project area to increase channel and bank roughness, channel hydraulic complexity, available cover, and functional habitat. Additionally, these structures are often placed in conjunction with other wood features to help promote specific geomorphic responses and habitat functions, as is described further in Section 7. During further stages of design, stability analyses will be conducted for the various LWM structures to determine if any of these proposed features would require anchoring. Anchoring may be through wedging pieces of wood between existing trees along the banks, utilizing streambed boulders, or by burying a portion of the LWM. Collaboration will continue with various interest groups to determine the need for anchoring and minimizing LWM transport of a specific size (See Section 5) into Reach 1 and Lake Sammamish depending on the location of the LWM structure.

Figure 5. Wood Structure Example: Single Pieces, Log Jacks, and Small Spur Jams

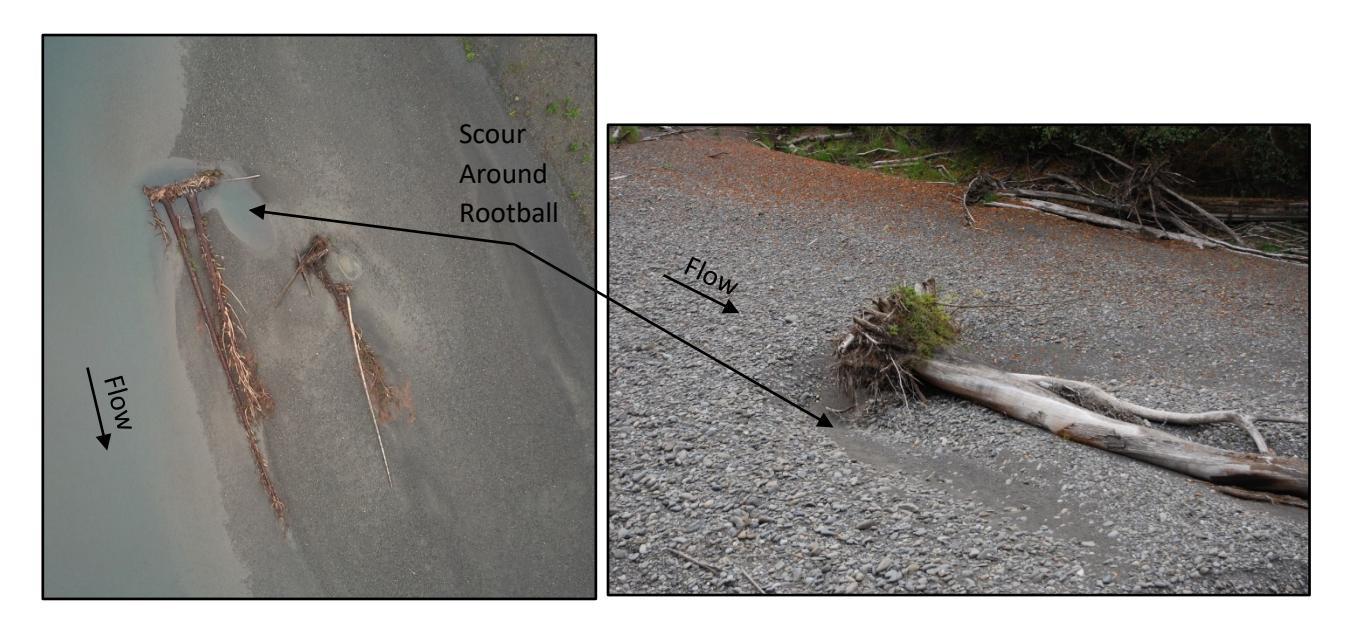
Photo 20 depicts single pieces of wood and how they can provide functional habitat. At the front of the LWM shown in Photo 20, velocities accelerated around the rootballs, which scoured out the bed material and created a small pool. At some low-flow elevations, velocities in these types of small pools effectively becomes negligible. These types of temporal low-flow habitats, which are typically connected, but away from, mainstem flows, are frequently used by salmonid fry. Behind the rootball, velocities slowed down which allowed the channel to deposit sediment, forming bars. The Log Jack structures are designed to provide an amplification of this specific response to what you see in nature with single piece LWM structures. The triangle pieces of wood anchored around the rootball will function as an extension of the rootball itself, increasing the pool creation at the rootball and bar formation behind it.

Photo 20. Wood Structure Example: Single Pieces

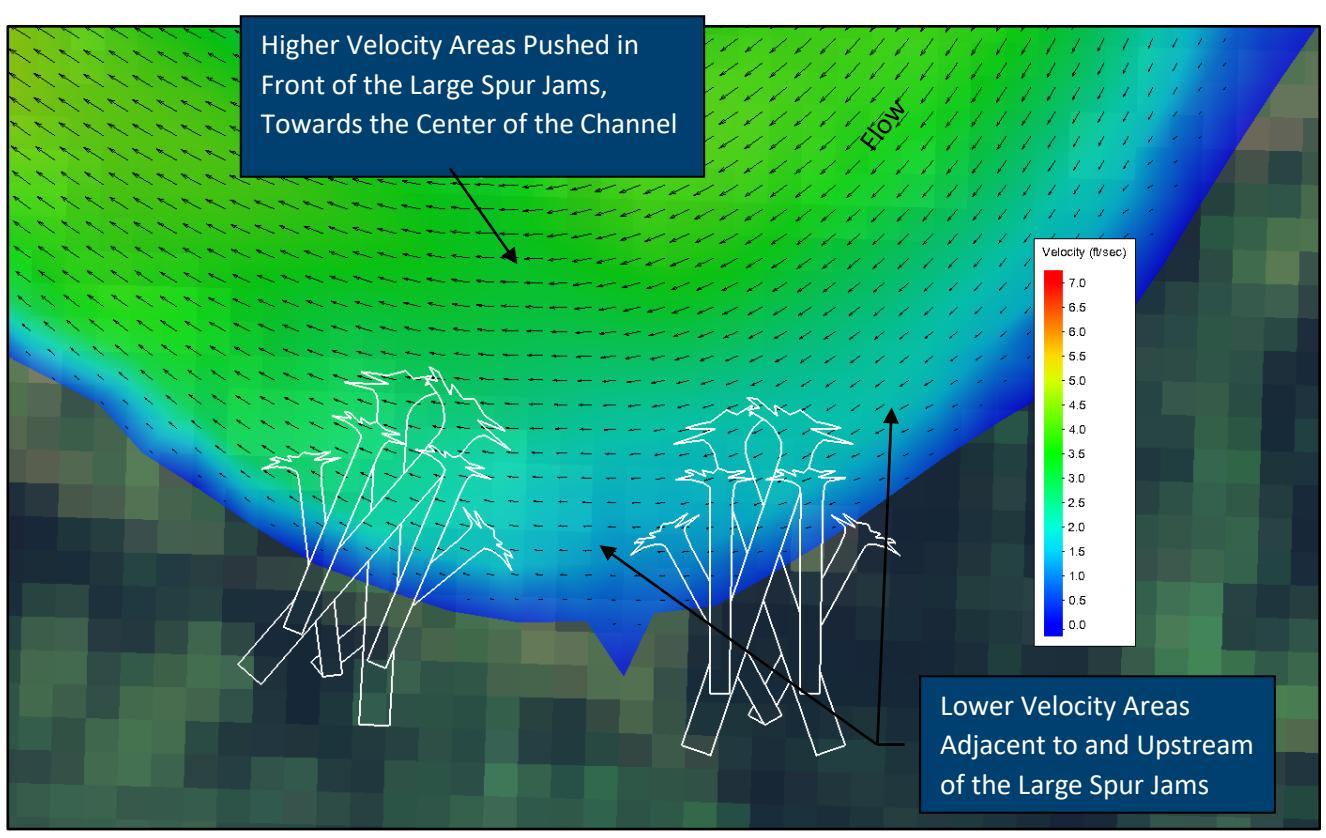
The large spur jams are strategically utilized throughout the project area to provide various functions. Depending on the specific placement of each structure, they are intended to increase channel and bank roughness, channel hydraulic complexity, and available cover. They are also intended for promoting aggradation and channel migration/sinuosity, redirect and split flow, and/or provide cover and functional habitat. These large spur jam structures consist of two, 3-foot diameter, 30-foot long logs with rootwads and four, 2-foot diameter, 20-foot long logs with rootwads (see Appendix F, Sheet LWM 5).

Figure 6. Wood Structure Example: Large Spur Jams

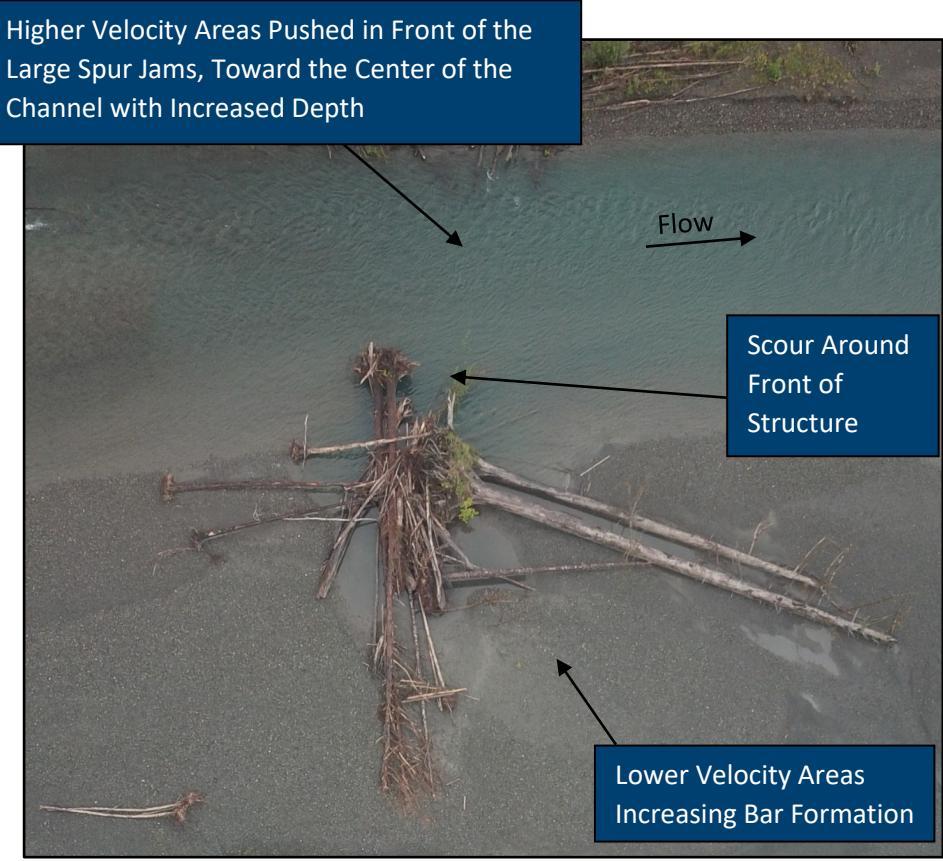
Photo 21. Large Spur Jam – Velocity Influence Example

The largest LWM structures utilized in the preferred design alternative are the apex jams. Figure 7 and Photo 24 show an example of how the apex jams affect the hydraulic characteristics of the channel near the wood structure. The apex jam structures consist of two, 3-foot diameter, 30-foot long logs with rootwads, and ten, 2-foot diameter, 20-foot long logs with rootwads (see Appendix F, Sheet LWM 6). These structures are strategically placed throughout the project area to primarily promote channel sinuosity, split flow, and provide wood recruitment. However, they also promote aggradation, provide channel complexity, increase cover, and provide functional habitat. The apex jam depicted in Figure 7 is located in Reach 4 at approximately Station 59+75 (Appendix F, Sheet PR 13, #88). As is depicted in the figure, flow is pushed around the outsides of the apex jam, increasing velocities as it moves around the structure while also providing a hydraulic shadow directly behind the apex jam. This hydraulic shadow promotes aggradation and bar formation while also providing a place of refuge for aquatic species. At nearly all flow stages, apex jam features typically support (both directly and indirectly) a high range of diverse habitats available to various life stages of most native fish species. Photo 25 depicts juvenile salmonids utilizing a large LWM structure constructed on the Skagit River for refuge. Similar to the large spur jams, the increase in channel velocity around these structures would be expected to not only split flows, but also promote the creation of pool areas adjacent to and under the wood (see Photo 21).

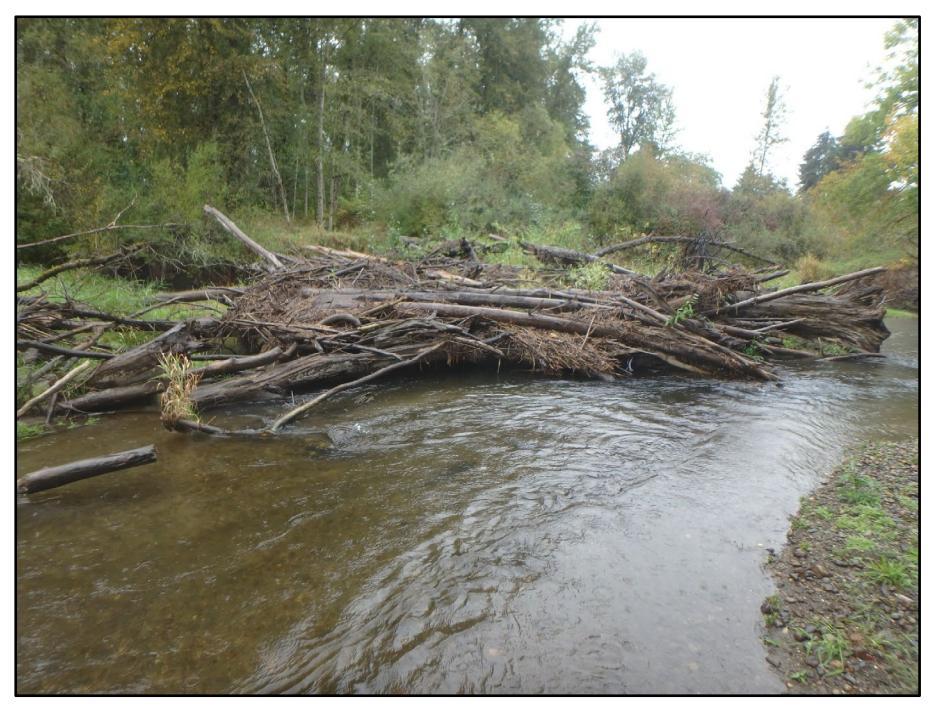
Photo 22. Large Spur Jam Example

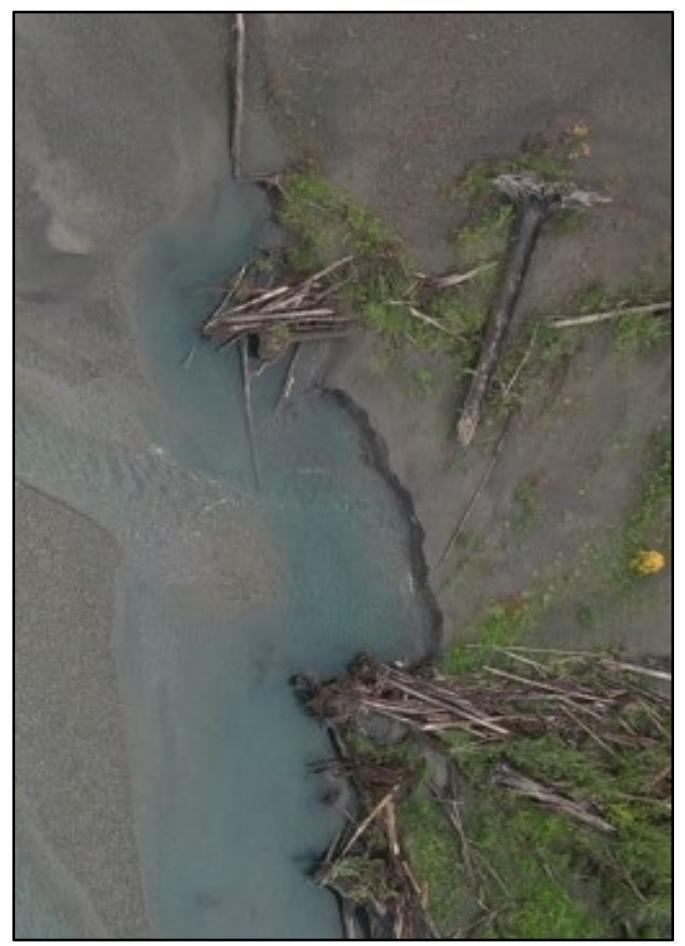
life stages of important native species. Photo 23 shows an aerial view of how bank erosion can be formed near large spur jams, promoting aggradation and increased sinuosity.

Photo 23. Large Spur Jam – Bank Erosion Example

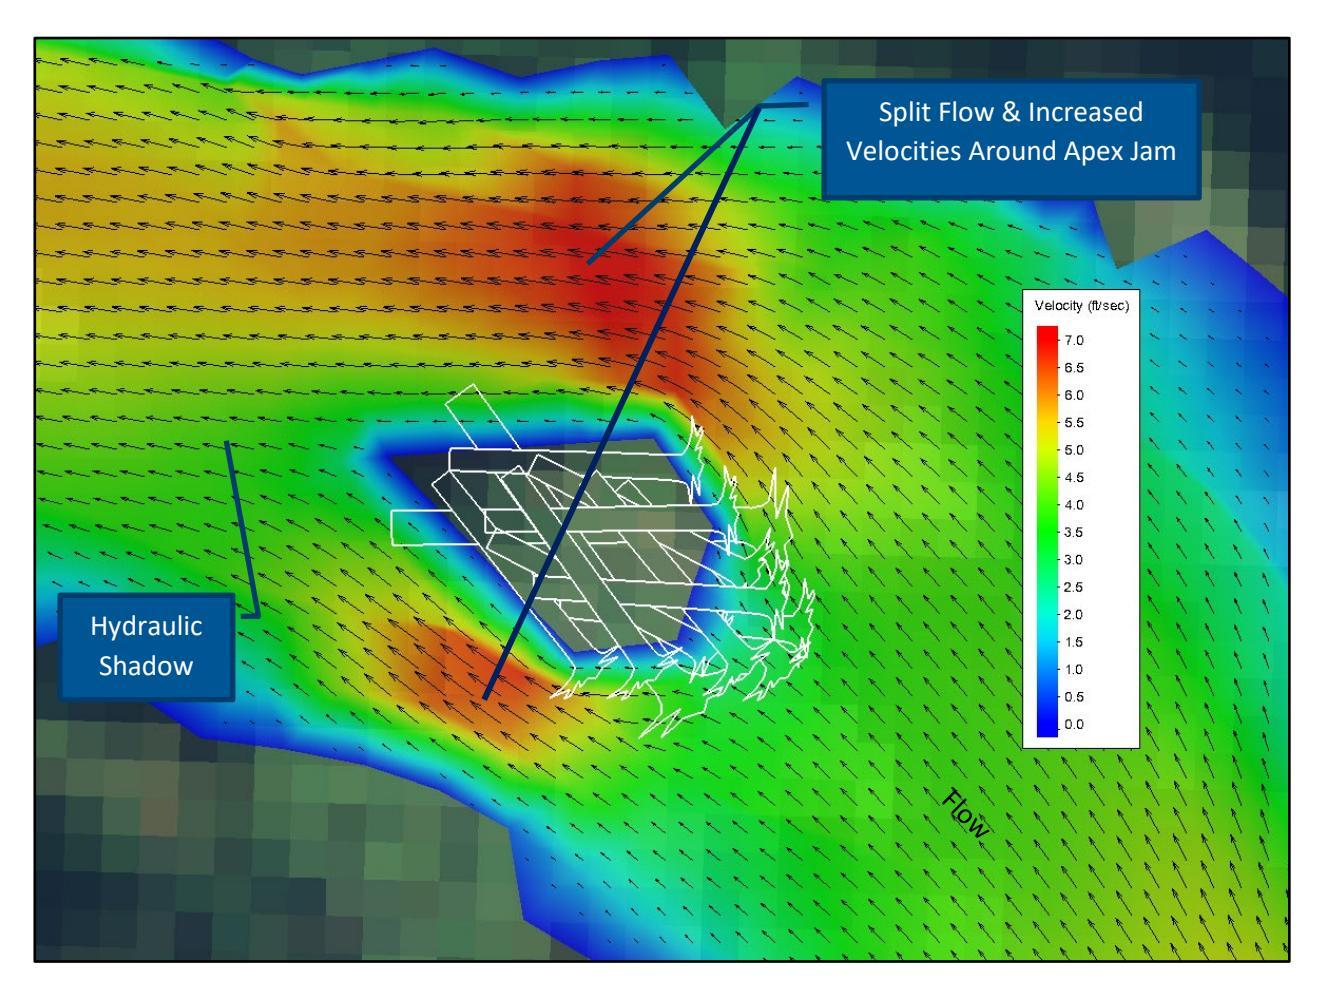
Figure 7. Wood Structure Example: Apex Jams

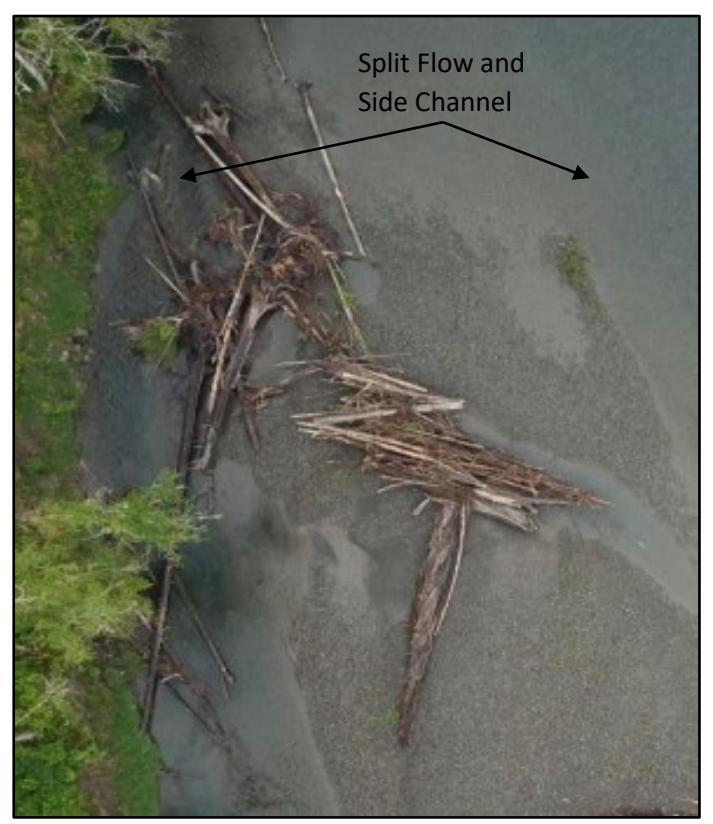
Photo 24. Apex Jam – Split Flow Example

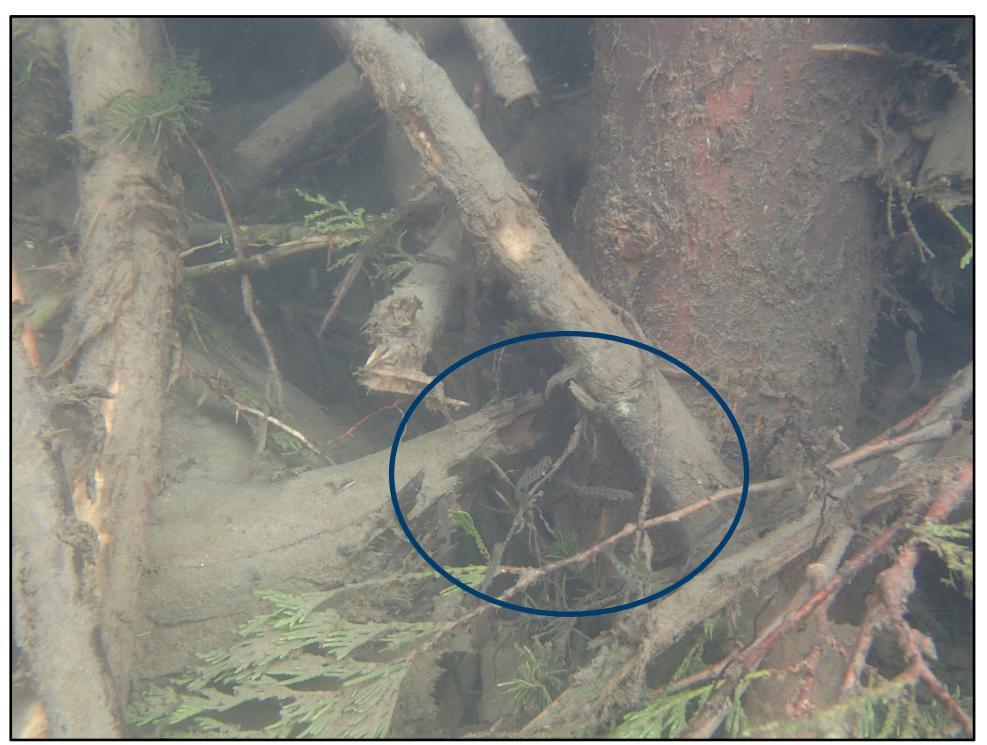
Photo 25. Juveniles Utilizing a LWM Structure For Refuge

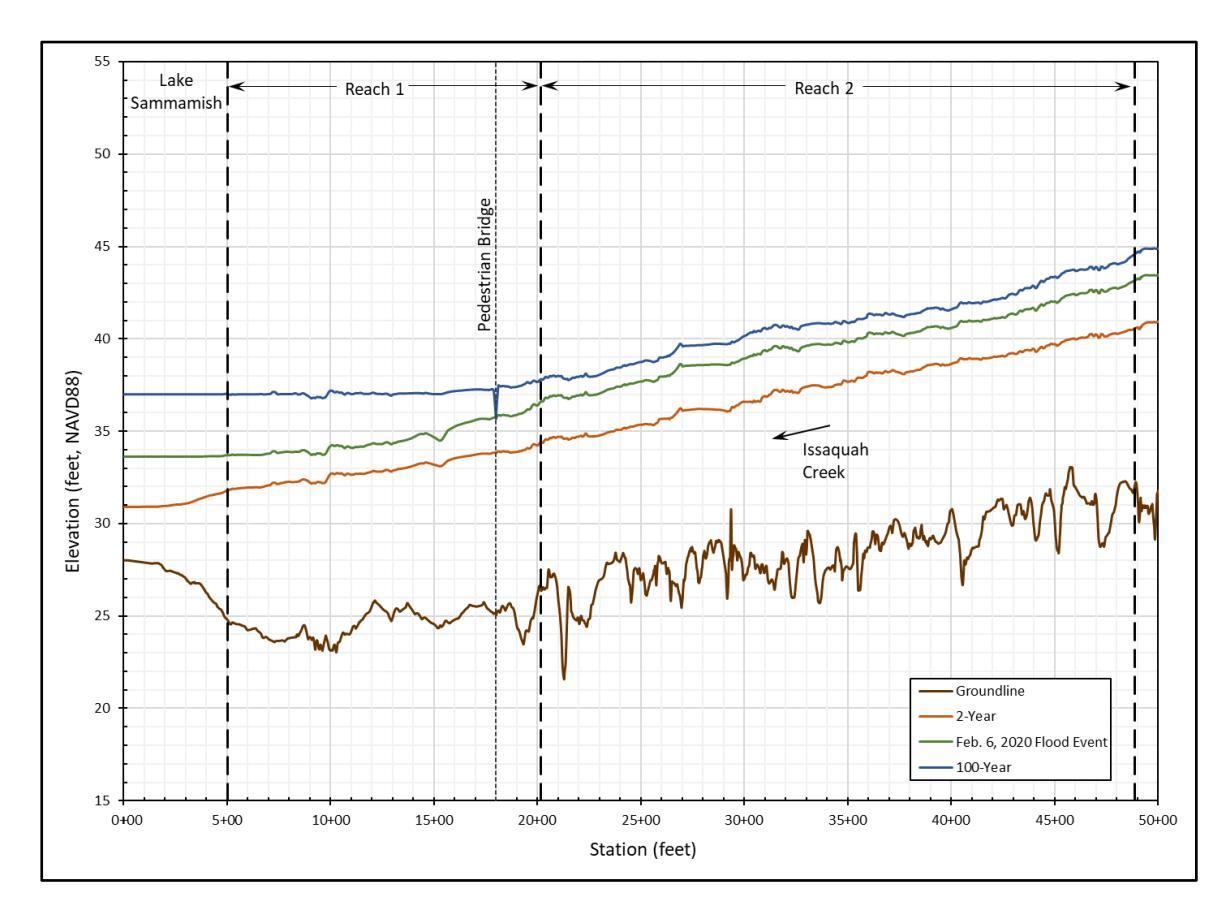
Figure 8 contains a longitudinal profile for the creek and includes the modeled 2-year, February 6, 2020 flood event, and 100-year water surface profiles. The backwater influence from Lake Sammamish, which varies depending on the lake level and magnitude of the modeled peak flow, is visible in the water surface profiles. Through the sensitivity analysis on lake elevation, as described in Section 8.1.3, it was determined that Reach 1 and the lower portions of Reach 2 will be influenced by the lake elevation even during low flow conditions.

Figure 8. Water Surface Profiles for Issaquah Creek in Reaches 1 and 2

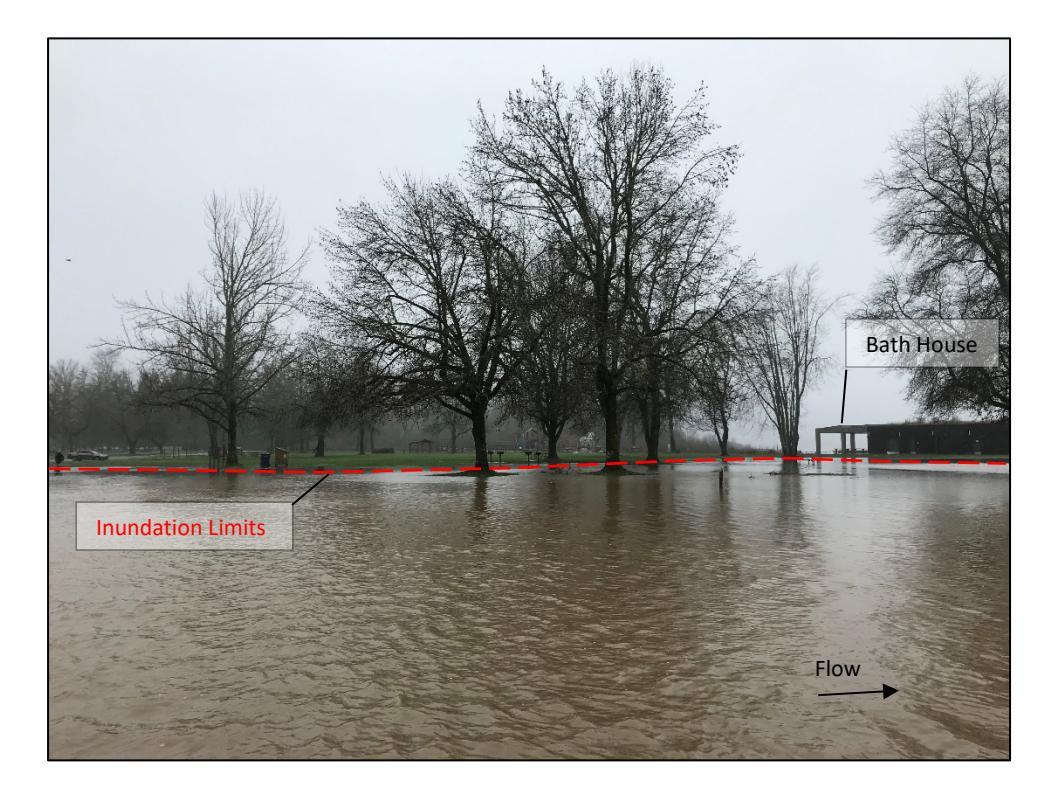
Model results for the February 6, 2020 flood event were compared to photographs taken by The Greenway Trust personnel near the time of the peak recorded flow value. Figure 9 shows the inundation limits of the flooding across the parking area and near the bath house. Consistent with the model results for the flood event (Appendix G, Figure G.5), a significant portion of the parking lot is inundated, but the bath house and playground in the background of the photograph remained dry.

Figure 9. Inundation Extents of February 6, 2020 Flood Event Near Bath House

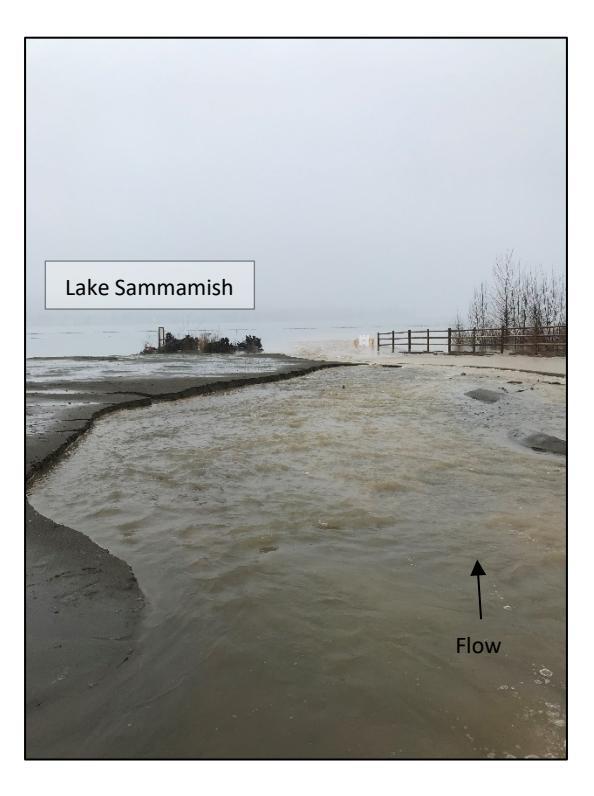
Figure 10 shows overbank flood waters running down the pedestrian trail near the bath house and onto Sunset Beach. State Park Staff have mentioned this area of the beach often loses material during larger flood events. During the February 6, 2020 event, The Greenway Trust personnel noted that sand was eroded during the flood in this area. The model results indicate higher velocities in this area relative to the other overbank velocities (Appendix G, Figure G.6), consistent with the observed erosion and higher velocity water evident in Figure 10.

Figure 10. Water Flowing onto Sunset Beach During February 6, 2020 Flood Event
